Liquefaction Impact on Critical Infrastructure in Christchurch

Final Technical Report

March 22, 2013

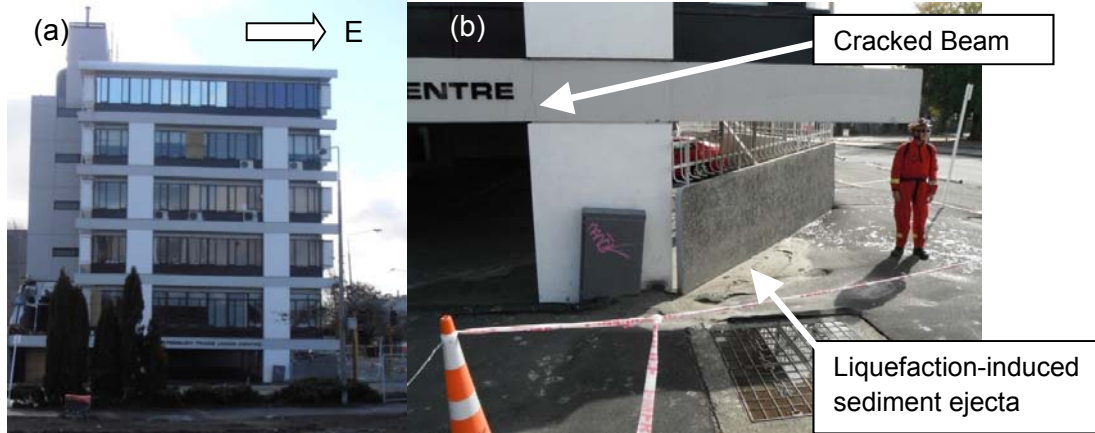
Figure 2.5. (a) South end of CTUC Building showing tilt to the east (taken July 2011) and (b) Close-up photograph of the SE corner of the building (taken March 2011).

While damage to the building was negligible during the Darfield and June 2011 events, severe liquefaction of the foundation soils during the Christchurch earthquake induced significant total and differential settlements of the building, leading to structural distortions and cracking (Cubrinovski et al. 2011a). The building tilted to the east 0.4-0.5 degrees. Differential settlement of the SE corner of the building produced most of the structural damage. Several of the exposed beams on the south side of the building were cracked near the beam-column connections (Fig. 2.5b). Building settlement measurements were performed using the building located just to the north of CTUC Building as the datum, as it did not displace relative to the surrounding ground. The settlement measurements are presented in Fig. 2.6. The building settled more on its south side than on its north side and more on its east side than its west side. Approximately 20 cm of the 25 cm of differential building settlement along the eastern side of the building was measured over the combined length of the two southernmost spans (angular distortion $\approx 1/50$). Thus, cracking of structural beams in this area is not surprising.

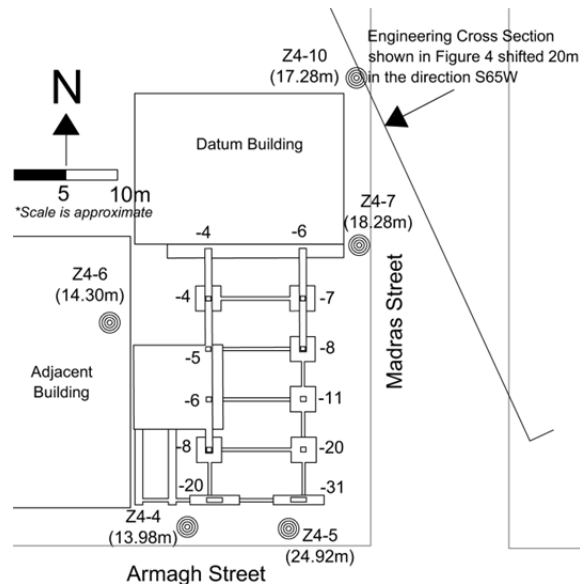
Figure 2.6. CTUC Building site with its foundation system and CPT locations (with depths). Footing settlements at column locations relative to the datum building are provided in cm.

Free-field vertical settlements due to post-liquefaction volumetric strains suggest a differential settlement of about 6 cm across the building due to the Christchurch earthquake. However, the building actually settled differentially 25 cm more at its south end than at its north end for this event. Ground loss under the shallow foundations due to sediment ejecta likely led to larger settlements. Moreover, shear-induced mechanisms such as SSI-ratcheting likely contributed to larger settlements at the SE corner of the CTUC building. Liquefaction of soils below a depth of 8 m contributed significantly to the amount of calculated settlement, but their impact on the building performance was relatively minor.

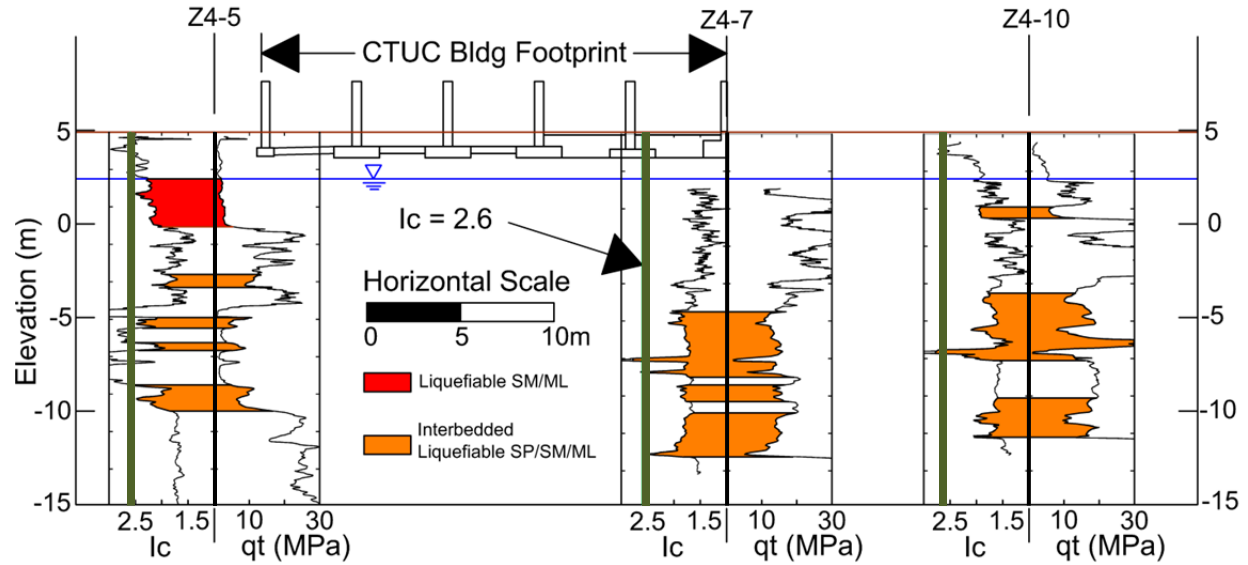
Figure 2.7. Subsurface conditions at CTUC site showing zones of materials with $FS_l < 1.0$ based on the RW98 procedure using PGA_{50} from Bradley and Hughes (2012) for the Christchurch earthquake.

Simplified liquefaction evaluations were performed utilizing the procedures described previously. From examining Fig. 2.7, it is clear that while there are liquefiable soils at each of the CPT locations, the distinguishing difference between them is that CPT Z4-5 indicates that there are shallow liquefiable soils just beneath the building foundation whereas the liquefiable soils at CPTs Z4-7 and Z4-10 are located primarily at depths below 8 m. The dramatic change in the shallow soil conditions from the building's north end, which did not contain shallow liquefiable soils, to its south end, which contained shallow liquefiable soils, led to significant differential settlement over the southernmost spans of the building frame.

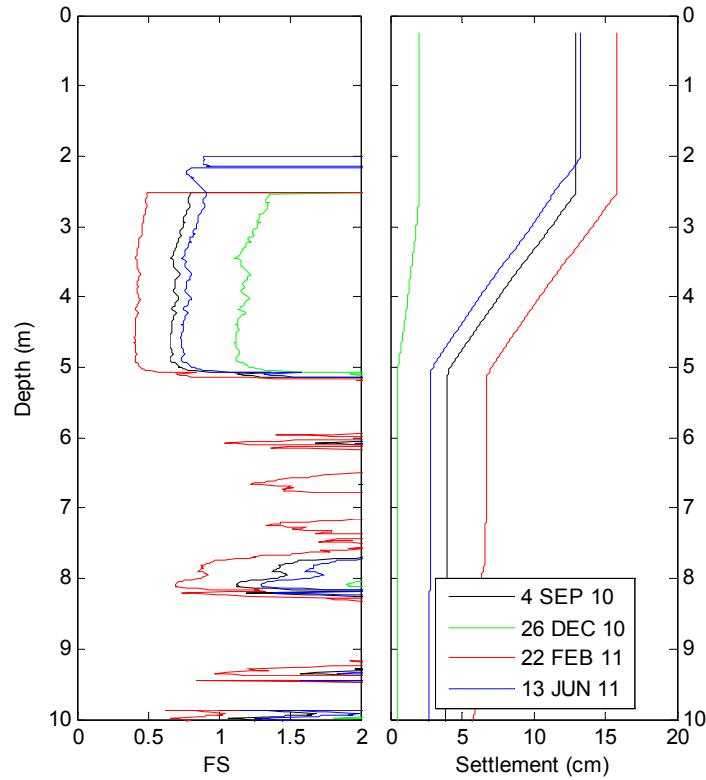
The calculated FS_l profiles for four events at CPT Z4-5 are presented in Fig. 2.8 for the median PGA estimates. As discussed previously, low FS_l values were calculated in the shallow SM/ML layer for the intense Christchurch earthquake, wherein severe liquefaction was observed at the site. However, FS_l values below one are also calculated for the Darfield and June 2011 earthquakes. Although there were no reports of liquefaction at this location after these events, it is possible that a minor amount of liquefaction was unreported or that marginal liquefaction occurred and surface manifestations were not observed. Damage was not reported for these events, so if liquefaction did occur its effects were insignificant. Liquefaction triggering procedures are deliberately conservative, so it is also possible that liquefaction did not occur at this site although the calculated FS_l values were below one.

Figure 2.8. FS against liquefaction triggering and settlement due to post-liquefaction volumetric strain profiles at CPT Z4-5 using ZR02-RW98 and PGA_{50} estimates from Bradley and Hughes (2012).

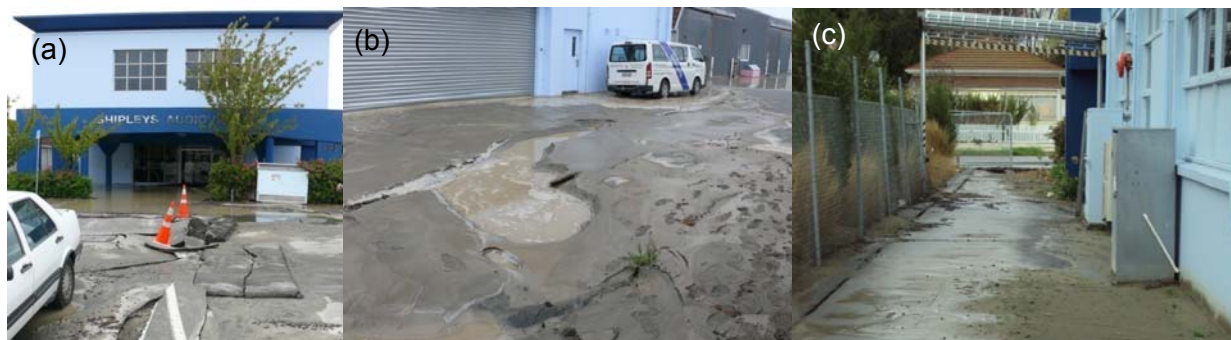
Liquefaction was far more severe and damaging during the Christchurch earthquake. Figure 2.9 illustrates severe ground cracking in the road south of the building and the extent of the ejected groundwater pond near the entrance of the building, which was reported to be 0.5 m deep, as well as the extent of liquefaction just north of the building. The building was surveyed by UCB-UC researchers in March 2011 and again in July 2011. During the March 2011 survey, Cubrinovski et al. (2011a) observed nearly continuous sediment ejecta around the perimeter of the building and evidence of its foundation displacing downward into the surrounding ground with the ground floor at the south entrance of the building uplifted and blistered. The building settled approximately 25 cm relative to the surrounding ground at its SE corner and approximately 10-20 cm at its NW corner. Due to this damage, the building was demolished in 2012.

Figure 2.9. (a) Views of the south end and (b) north end of SA Building taken approximately 2 hours after the Christchurch earthquake. (c) Photo of the east side of the building taken June 5th, 2011. (Photos courtesy of Shipleys Audiovisual Ltd.)

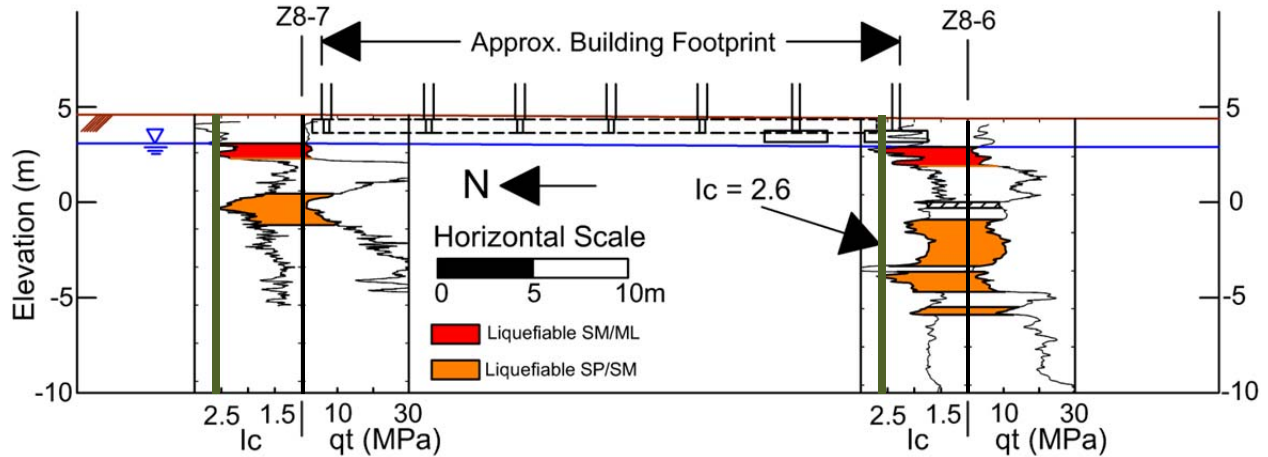
Three CPTs were performed at the SA Building site. The subsurface conditions along the length of the building are illustrated in Fig. 2.10. The site consists of a shallow SM/ML layer to a depth of 2-2.5 m with $q_t < 5$ MPa and $2 < I_c < 2.5$ similar to the shallow SM/ML layer observed at the CTUC and Armagh-Madras sites, which is underlain predominantly by sand and silty sands (SP/SM) until refusal was encountered. Tip resistance in the lower SP/SM unit was variable and was occasionally less than 10 MPa. The groundwater depth at the SA site was about 1.5 m throughout the Canterbury earthquake sequence (T&T 2012).

Figure 2.10. Subsurface conditions at SA site showing zones of materials with $FS_l < 1.0$ based on the RW98 procedure using PGA_{50} from Bradley and Hughes (2012) for the Christchurch earthquake.

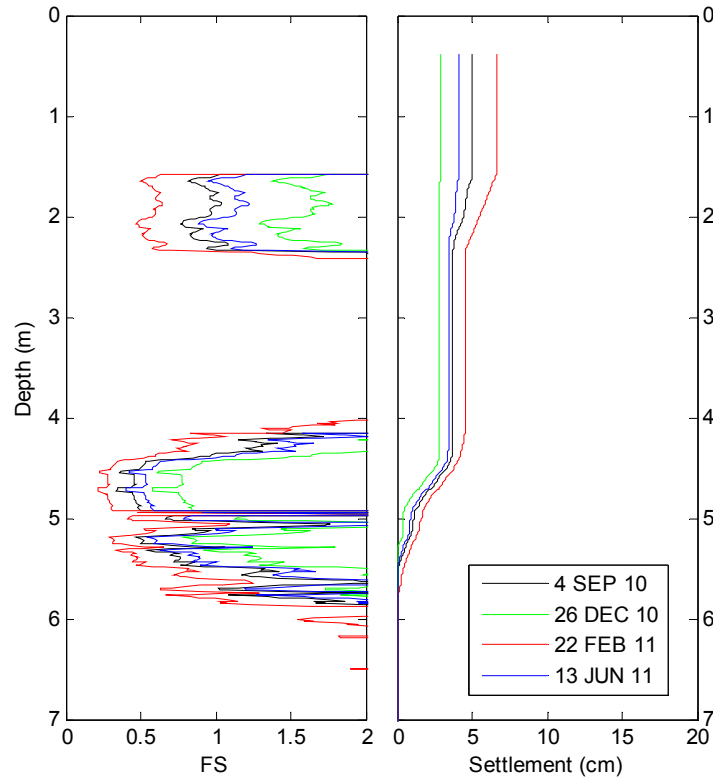
Figure 2.11. FS against liquefaction triggering and settlement due to post-liquefaction volumetric strain profiles at CPT Z8-7 using ZR02-RW98 and PGA_{50} estimates from Bradley and Hughes (2012).

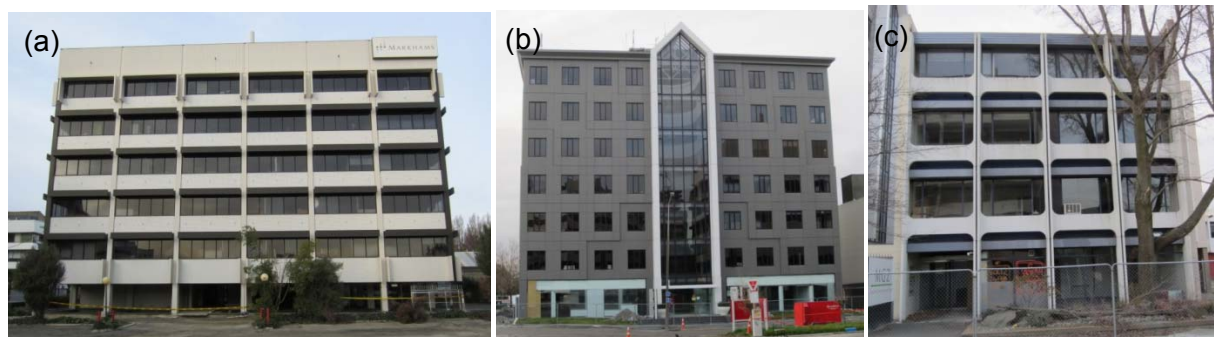
Figure 2.12. Zone 1 Building Group: (a) PILE-6, (b) FTG-7, and (c) FTG-4 buildings.

The FTG-7 Building, however, was damaged significantly with evidence of damage to the structural columns at the ground level. A floor level survey performed in March 2011 indicated approximately 10 cm of settlement of the SE corner of the building relative to the datum at its NW corner (Eliot Sinclair and Partners Ltd. 2011), and a subsequent building verticality survey (Beca 2011) confirmed the building was tilted to the S-SE. Relative settlements of the corners of the ground floor are indicated on Fig. 2.13. Post-liquefaction volumetric reconsolidation settlements from the Christchurch earthquake were calculated to be 25 cm at CPT Z1-B1, 28 cm at CPT Z1-B2, 24 cm at CPT Z1-B3, and 32 cm at CPT Z1-B4. Based on the observations of the settlement of the ground relative to the PILE-6 Building across the street, these estimates appear to be reasonable. However, the ground floor level survey indicated 7 cm of relative settlement of the SW corner (CPT Z1-B3) of the building to its NW corner (CPT Z1-B1). This differential settlement would not be estimated based on a direct comparison of the settlements calculated at CPT Z1-B1 and CPT Z1-B3.

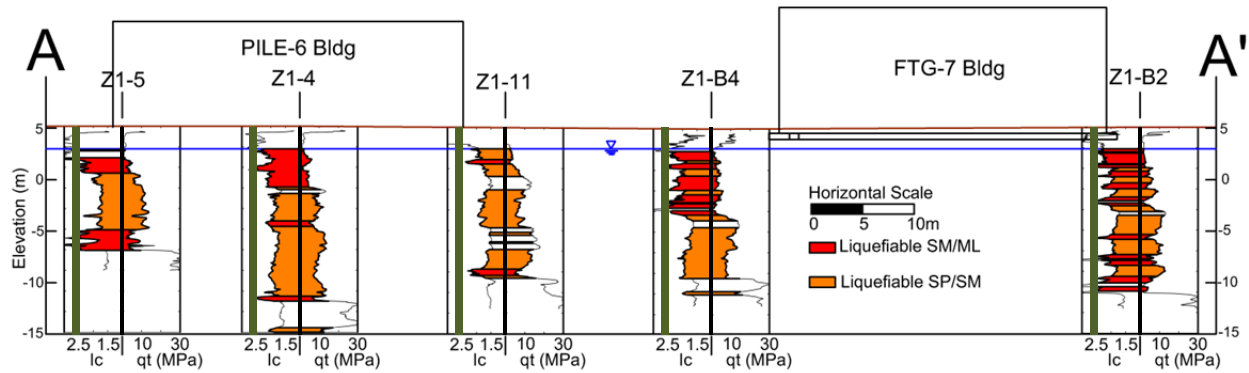
Figure 2.14. Subsurface conditions along section A-A' showing zones of materials with $FS_l < 1.0$ based on the RW98 procedure using PGA_{50} from Bradley and Hughes (2012) for the Christchurch earthquake.

Zones of materials with $FS_l < 1.0$ using the median PGA during the Christchurch earthquake are also indicated in Figs. 2.14 and 2.15. Significant liquefaction is calculated throughout much of the soil deposit for the Christchurch event. The FS against bearing failure was calculated using the procedures described previously, and the FS were estimated to be 1.4 for the southern strip footing of the FTG-7 Building and 2.8 for the strip footing supporting the eastern block wall of the FTG-4 Building. The free-field, level ground settlement estimates due to post-liquefaction volumetric strains over the upper 14 m of the soil deposit using the ZR02-RW98 procedure are summarized in Table 2.5. Significant settlements are estimated at most CPT locations as a result

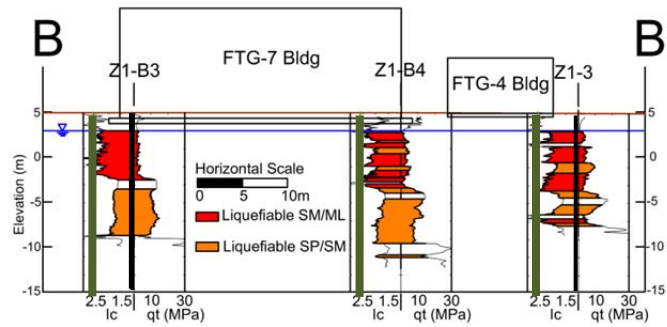
Figure 2.15. Subsurface conditions along section B-B' showing zones of materials with $FS_l < 1.0$ based on the RW98 procedure using PGA_{50} from Bradley and Hughes (2012) for the Christchurch earthquake.

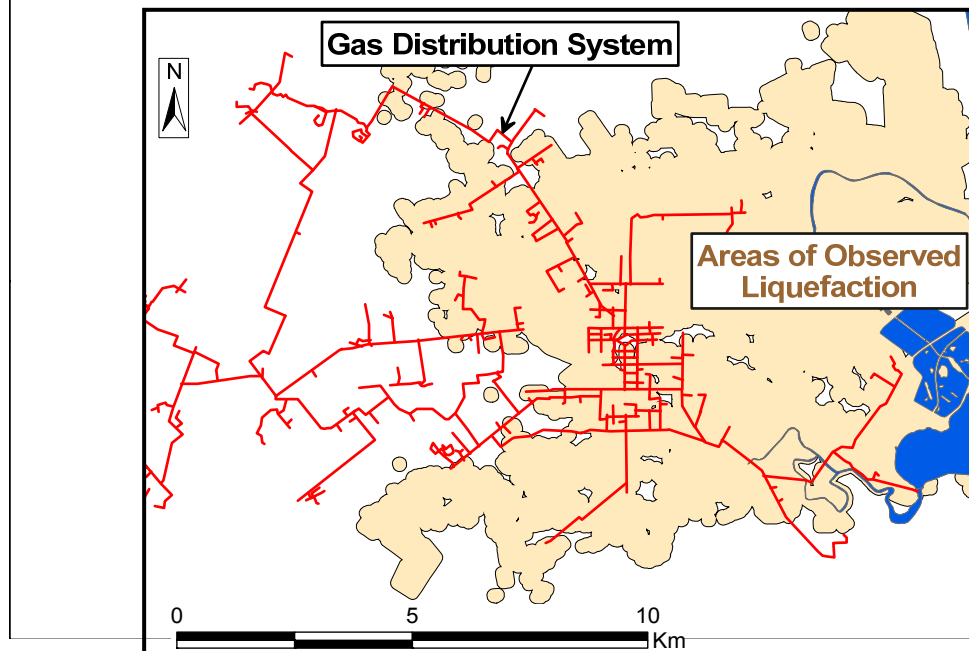
The absence of damage is related primarily to the strength and ductility of the MDPE pipelines. High and medium density polyethylene pipelines can sustain high levels of tensile strain without rupture. When the pipelines are constructed with good workmanship using high quality electrofusion welds, there is inherent ductility in both the pipe sections and their welded connections.

Figure 3.14. Gas distribution system and areas of observed liquefaction for the 22 Feb. 2011 earthquake.
