**INFRASTRUCTURE UPGRADES AND REPAIRS FOR IMPROVED
MONITORING OF CRUSTAL DEFORMATION AT PIÑON FLAT AND DURMID HILL**

Final Technical Report: May 31, 2011

Duncan Carr Agnew

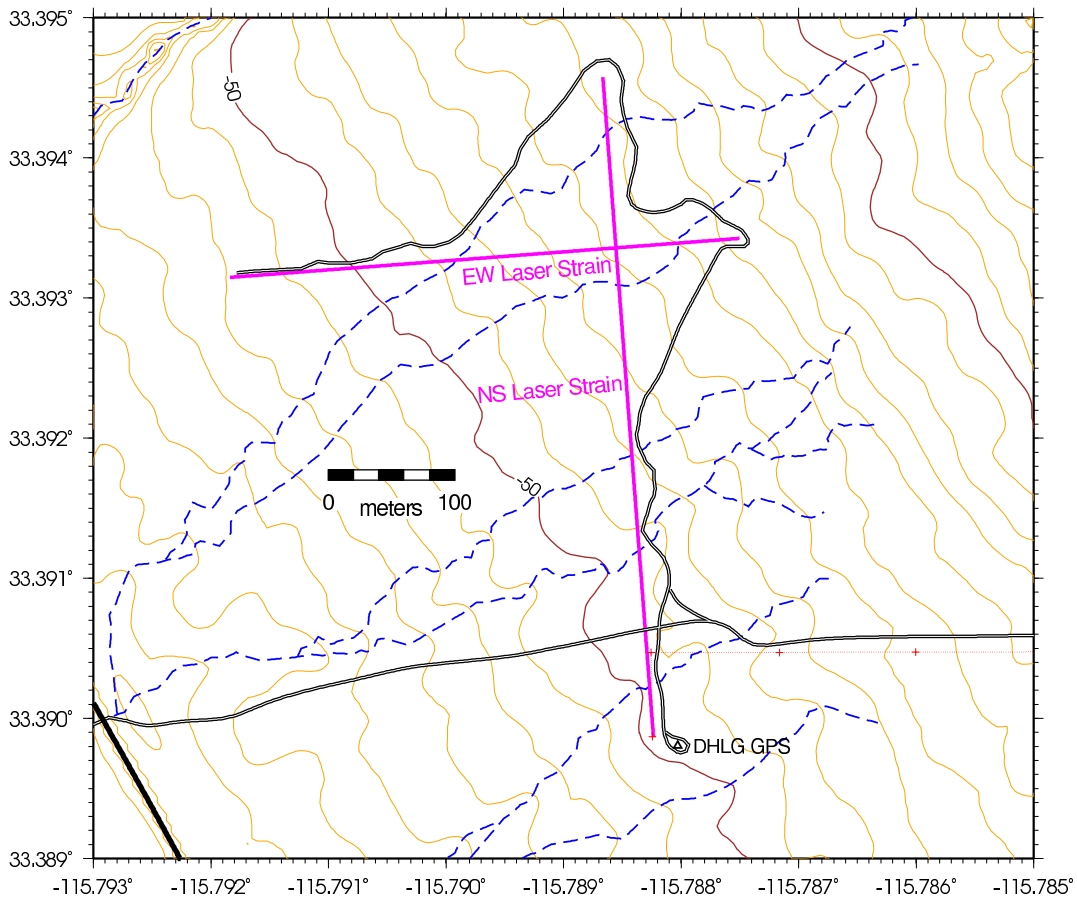
Figure 3

- **Strainmeter Bridges:** At Durmid Hill the NS strainmeter is completely buried; but where it crossed local washes (the larger ones are shown in **Figure 3** as dashed lines) we initially built special supports to bridge these with protective covers over the pipe. For access roads we used culverts covered with fill. Over time these fast-evolving flood-washes eroded further, exposing the strainmeter pipes and making the road culverts unsafe. At a number of the washes we restored the ravine walls with non-erodible material (sandbagged sand with some concrete), and repaired the culverts.
