Final Technical Report

Collaborative Research with William McCann and William Lettis & Associates Inc.: Analysis of the Effects of the 1918 Puerto Rico Earthquake and Calibration of Puerto Rico *Shakemap* Parameters

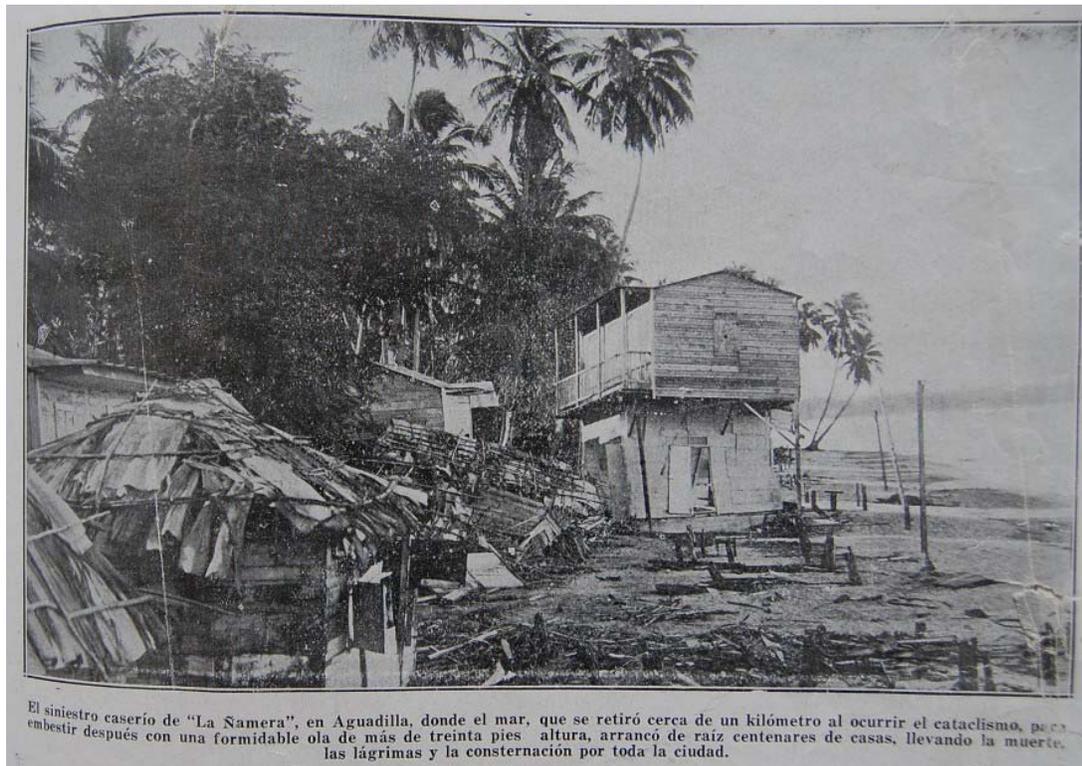
Figure 5

To the south, Zones 1 and 2 show progressive tsunami effects from west to east. Along Calle Betances (Zone 1), which lies 30 – 70m from the shoreline, houses closest to the beach were totally destroyed, while those to the north were knocked off their foundations and pushed inland. The house with the lowest address number, probably in the northern part of Zone 1, though severely damaged, did not mention tsunami effects. Figure 6, a photo taken looking south from the south end of Calle Betances in 1899 (undoubtedly after the severe hurricane of that year) shows what houses along the street looked like, albeit 20 years before the earthquake. Some of the Betances damage reports may be for houses shown in this photo.
