Mapping of Seismically Induced Landslipping in the Benton Hills and Crowley's Ridge, New Madrid Seismic Zone, Missouri and Arkansas

J. David Rogers

Briget C. Doyle

Department of Geological Sciences & Engineering
University of Missouri-Rolla

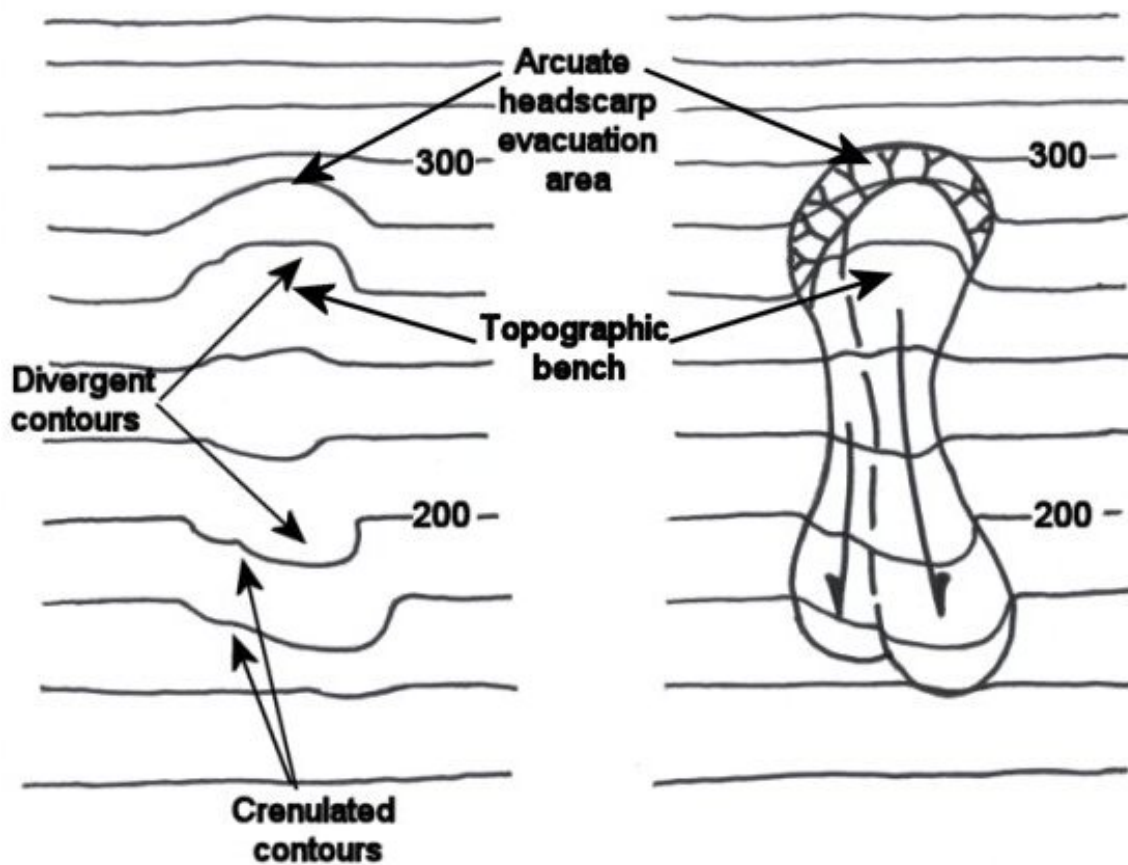
Figure 4.1 Illustration showing topographic anomalies used in landslide identification. The illustration shows a typical set of coalescing earth flows, although the anomalies may be related to other landslide types as well.

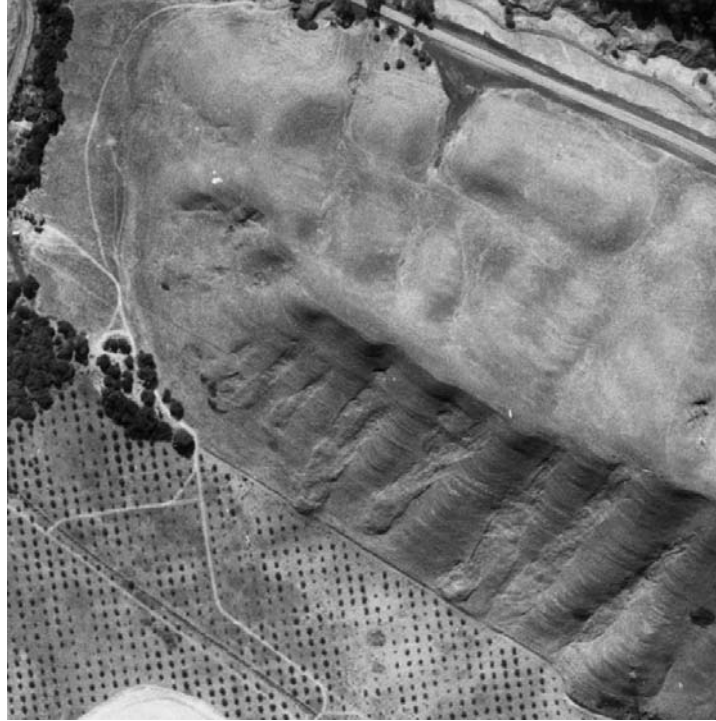
Figure 4.4 – Vertical photo of Campolindo Ridge in Moraga, CA, taken in 1946 with oblique backlighting, which shows a series of dormant earthflows to good effect.

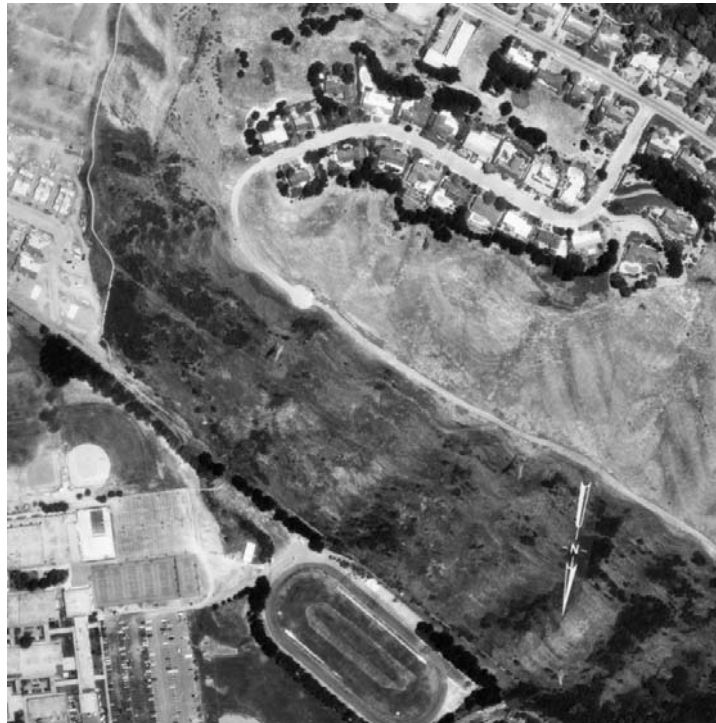
Figure 4.5 – The same view as the previous figure, but imaged in 1984, with morning sunlight shining directly on the slope. The earthflows seen on Figure 4.4 were reactivated in 1983, but are not discernable on this image.

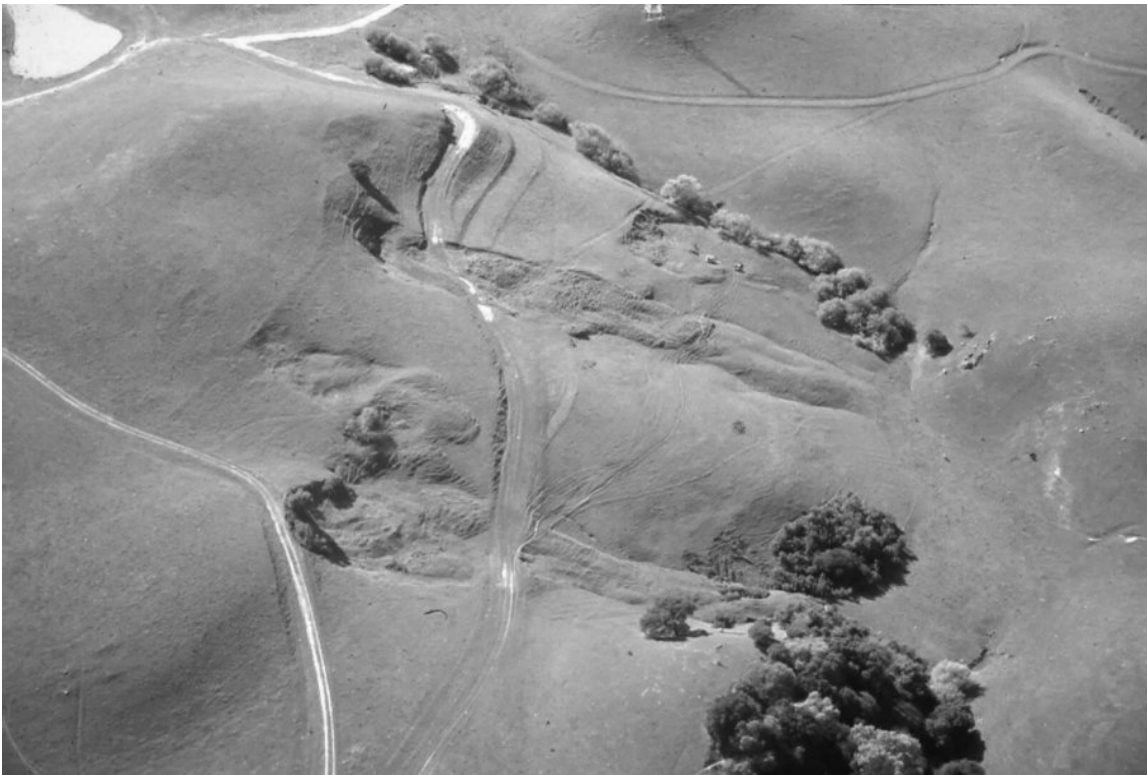
Figure 4.18 Earthflows occupying the axes and flanks of colluvial-filled bedrock ravines near El Sobrante, CA, imaged in January 1993. Earth flows on Crowley's Ridge exhibit the same topographic expression, but are more difficult to visualize on aerial photographs due to the dense vegetation.

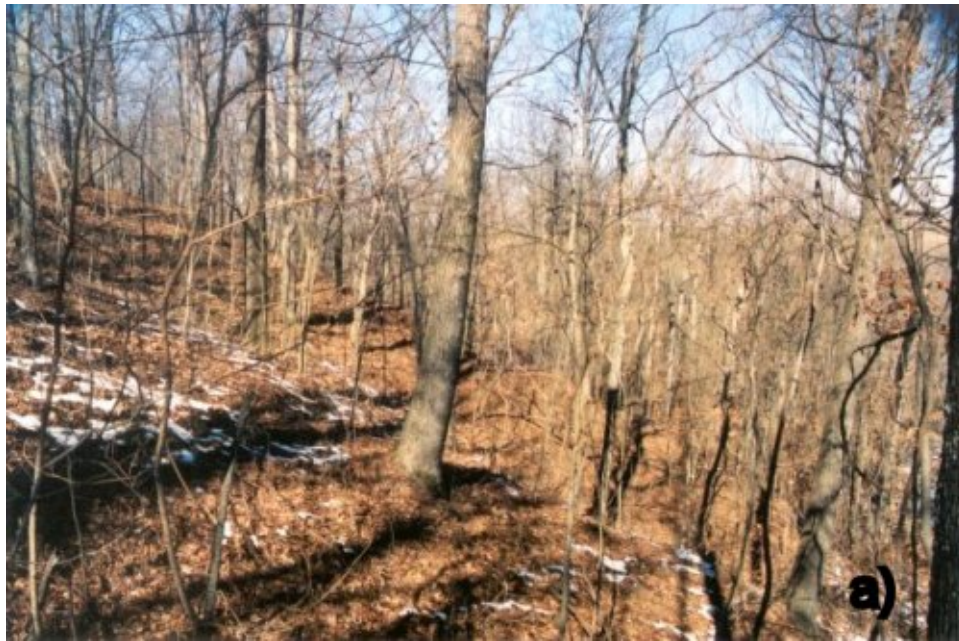
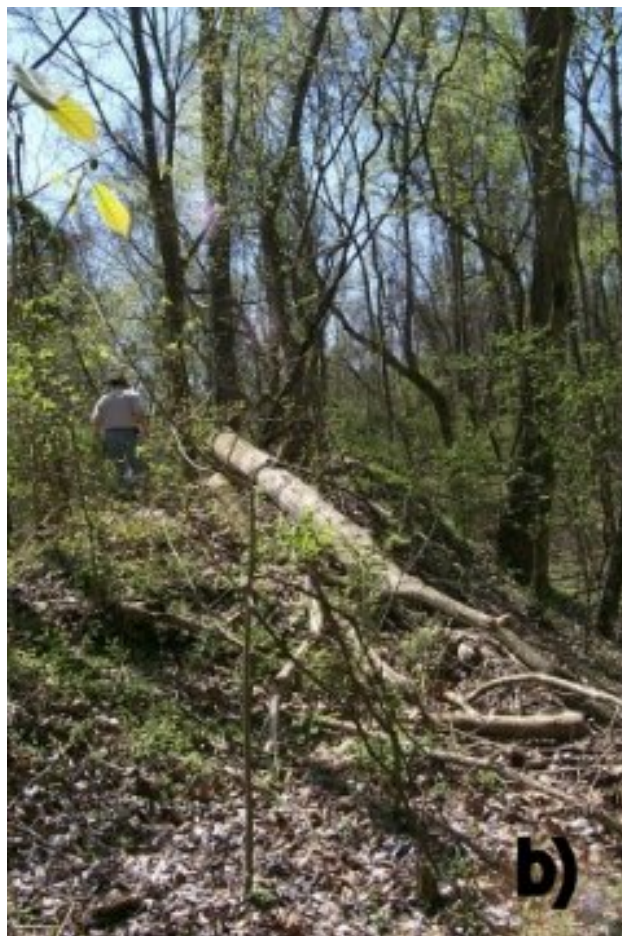
Figure 5.1 Photographs showing heavy vegetation on the slopes and at the base of Crowley's Ridge. a) within the Valley Ridge quadrangle, early February, 2003; and b) Helena, AR, mid March, 2003.

5.1.1. Landslide Verification Once the topographic maps were employed to tentatively identify areas of anomalous topography, field investigations were undertaken to verify the existence of actual landslides. Due to the highly vegetated nature of Crowley's Ridge (Figure 5.1) initial field investigations were conducted in early to mid spring. Field reconnaissance included looking for hummocky topography, head scarps, graben structures, deranged drainage, closed depressions, anomalous topographic benches, arcuate drainage and stepped or hummocky topography beneath the tree canopy. It was soon appreciated that the actual topography below the tree canopy was quite different from the topography mapped on the USGS 7.5-minute quadrangles, especially along the east-facing escarpment of Crowley's Ridge. The topographic maps of Valley Ridge, MO, and the Helena, AR, area were prepared from orthorectified stereopair aerial photography. Most of the steeply inclined slopes are masked by a dense tree cover. In areas with tall trees, the tree canopy tends to act as a reflective surface, making interpretation of the underlying topography difficult, as discussed in Subsection 4.1.4 and shown in Figure 4.6. The field work suggested that all too often, the topography of heavily vegetated hillslopes is interpolated linearly, between areas of bare earth, such as roads or ridgetops. Figure 5.2 illustrates how the thick tree canopy and tree height along the base of Crowley's Ridge has interfered with accurate mapping of topography. Errors in topographic mapping made it difficult to identify small landslides on topographic maps, but the larger landslide features are often discernable because they are of greater scale than the tree canopy.

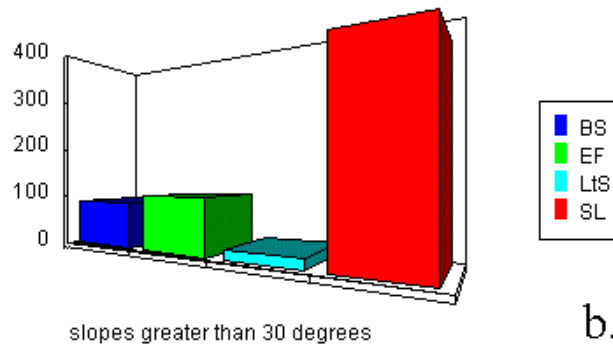
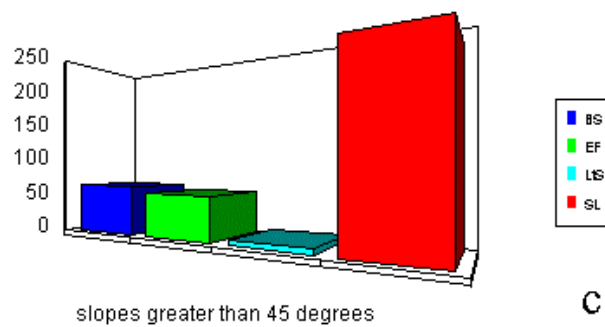
Figure 6.2 Distribution of slides with respect to degree of slope for the Valley Ridge quadrangle. a) distribution of landslides on slopes 15° or greater; b) distribution of landslides on slopes 30° or greater; c) distribution of landslides on slopes of 45° or greater. BS – block slide, EF – earthflow, LtS – lateral spread, SL – slump

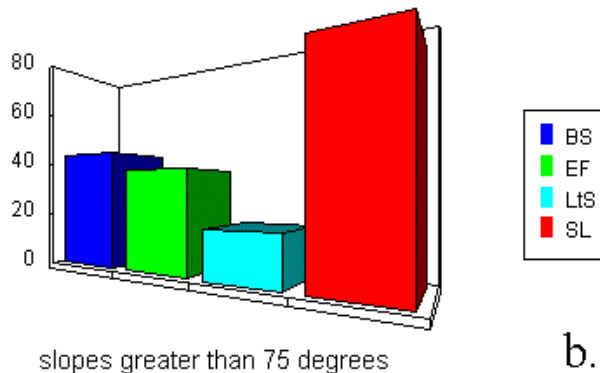
Figure 6.3 Distribution of landslides with respect to slope inclination for the Helena, AR area. a) distribution of landslides on slopes 65° or greater; b) distribution of landslides on slopes 75° or greater. BS – block slide, EF – earthflow, LtS – lateral spread, SL – slump
