U.S.G.S. Award Number: G20AP00079
Project Dates: 06/01/20 – 05/31/21

Detailed Evaluation of Insightful Liquefaction Ejecta Case Histories for the Canterbury Earthquake Sequence, New Zealand

Final Technical Report

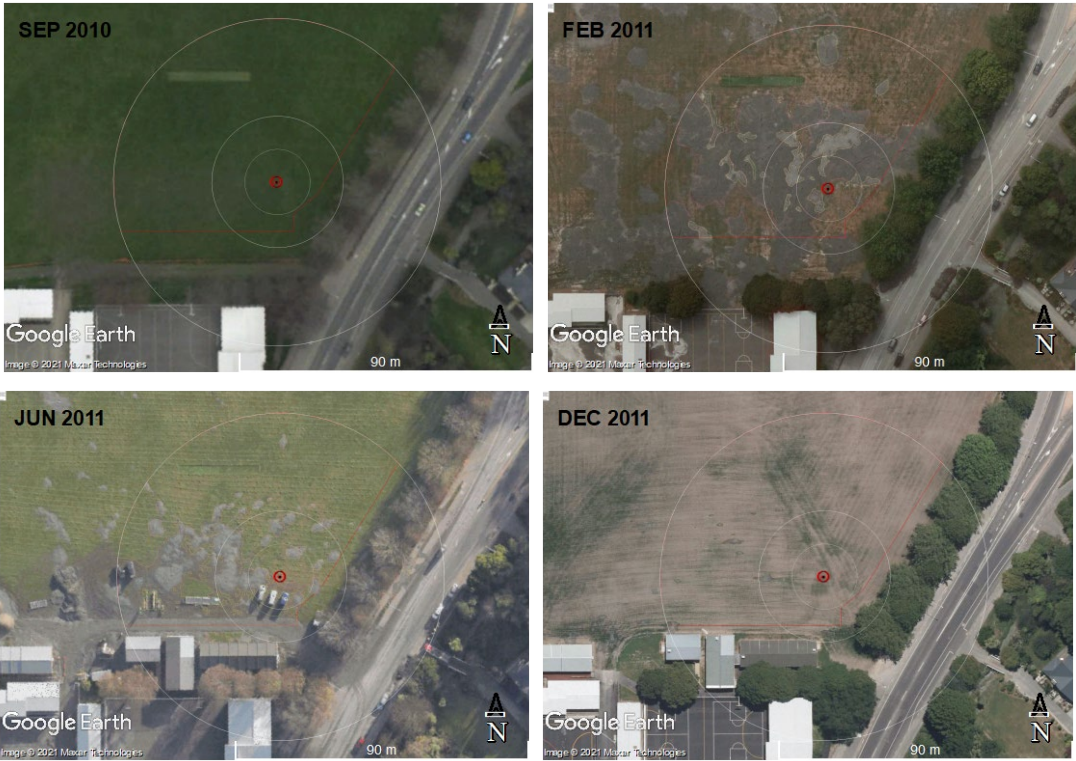
Figure 9: Aerial photographs acquired for Shirley Intermediate School in Sep 2010, Feb 2011, June 2011, and Dec 2011 (CGD 2012a) with ejecta outlines for the 10-, 20-, and 50-m buffers.

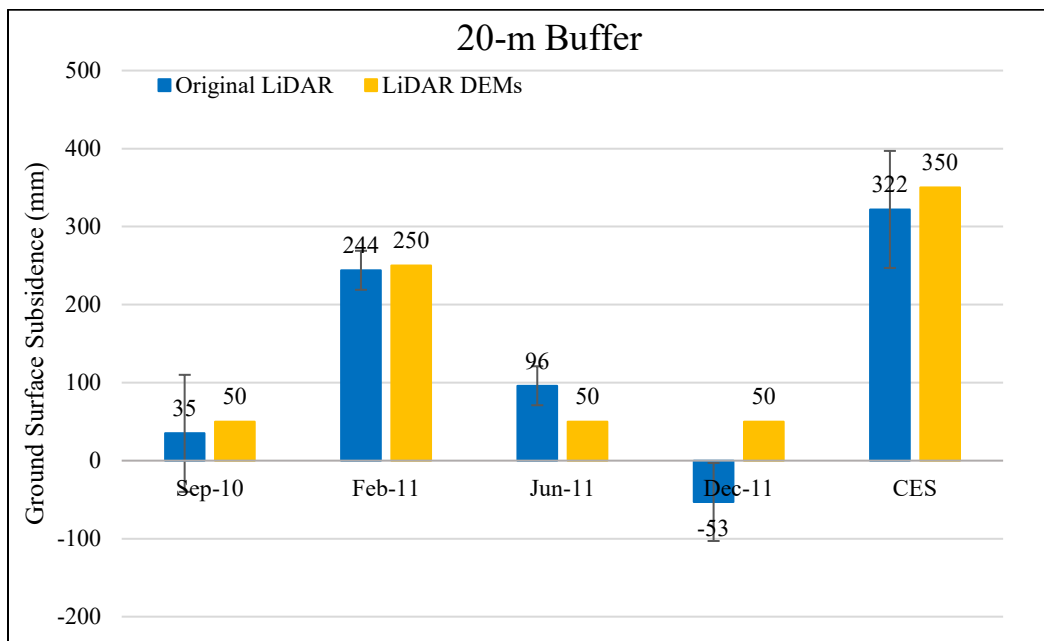
Figure 12: Comparison between the ground surface subsidence determined using the individual LiDAR elevation points and the ground surface subsidence estimated using the LiDAR DEMs.

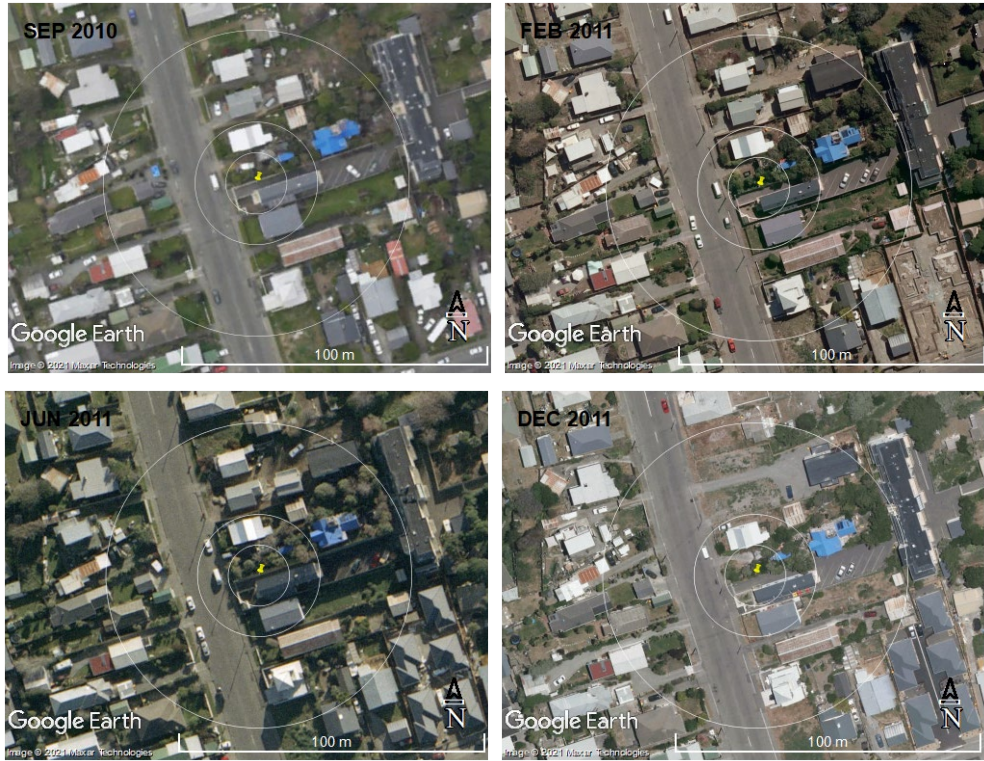
Figure 14: Aerial photographs for the Tonks St site acquired in Sep 2010, Feb 2011, June 2011, and Dec 2011 (CGD 2012a).

The Tonks St site (172.724500°, -43.493746°) is in the NE quadrant of Christchurch, approximately 200 m to the west from the Pegasus Bay. It is in the residential area that has approximately 30% of its 10-m, 20-m, and 50-m buffer covered with residential buildings. Approximately 15% of 20-m and 50-m buffers is occupied by a paved (impervious) road that passes predominantly through their eastern portions. Vegetation covers 30, 20, and 30% of the 10-m, 20-m, and 50-m buffers, respectively. No lateral spreading was observed for any earthquake event. The site is mostly level apart from the properties in the western portion of the 50-m buffer that typically have sloped driveways as they are approximately 0.5 m above the elevation of the road. The front lawns at these properties are, therefore, retained by 0.5-m tall walls. No specific area was outlined for settlement assessment at this site because ejecta were absent for all earthquake events as evident from the high-resolution aerial photographs (Figure 14). The lack of inspection reports for the properties within the 50-m buffer was an additional piece of evidence that ejecta did not occur at the site. Thus, it was not necessary to consider the LiDAR surveys to conclude that the ejecta-induced settlement at the Tonks St site for the Sep 2010, Feb 2011, June 2011, and Dec 2011 earthquake is 0 mm, 0 mm, 0 mm, and 0 mm, respectively (Table 14).
