M 6.3, 140km ESE of Shingu, Japan

Origin Time: 2019-07-27 18:31:07 UTC (Sun 03:31:07 local)
Location: 33.1461° N 137.3250° E Depth: 367.0 km

PAGER Version 5

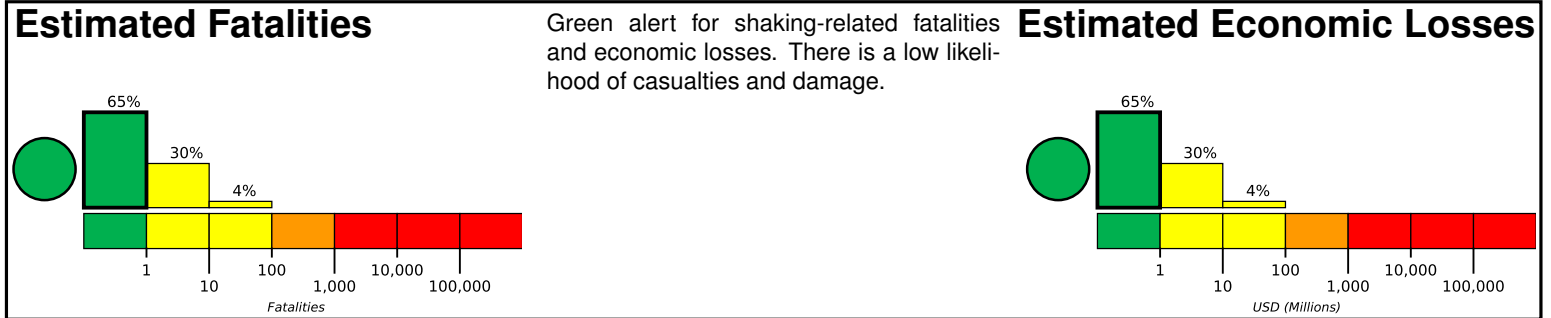
Estimated Population Exposed to Earthquake Shaking

ESTIMATED POPULATION EXPOSURE (k=x1000)		—*	228k*	0	0	0	0	0	0	0
ESTIMATED MODIFIED MERCALLI INTENSITY		I	II-III	IV	V	VI	VII	VIII	IX	X+
PERCEIVED SHAKING		Not felt	Weak	Light	Moderate	Strong	Very Strong	Severe	Violent	Extreme
POTENTIAL DAMAGE	Resistant Structures	None	None	None	V. Light	Light	Moderate	Mod./Heavy	Heavy	V. Heavy
	Vulnerable Structures	None	None	None	Light	Moderate	Mod./Heavy	Heavy	V. Heavy	V. Heavy

*Estimated exposure only includes population within the map area.
