USGS

Operator: Tom Noce Sounding: BKY013

CPT Date/Time: 11/8/2004 10:59:21 AM

Location: Brick Church Rd near stinking rottting deer carcass

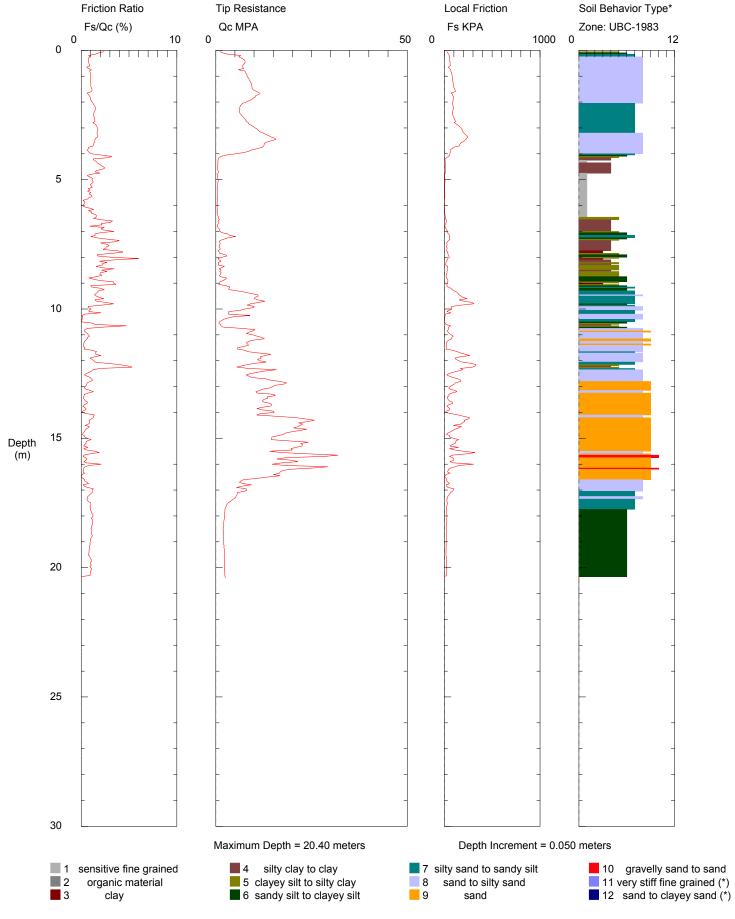
Cone Used: DDE0766
