Liquefaction Impact on Critical Infrastructure in Christchurch

Final Technical Report

March 22, 2013

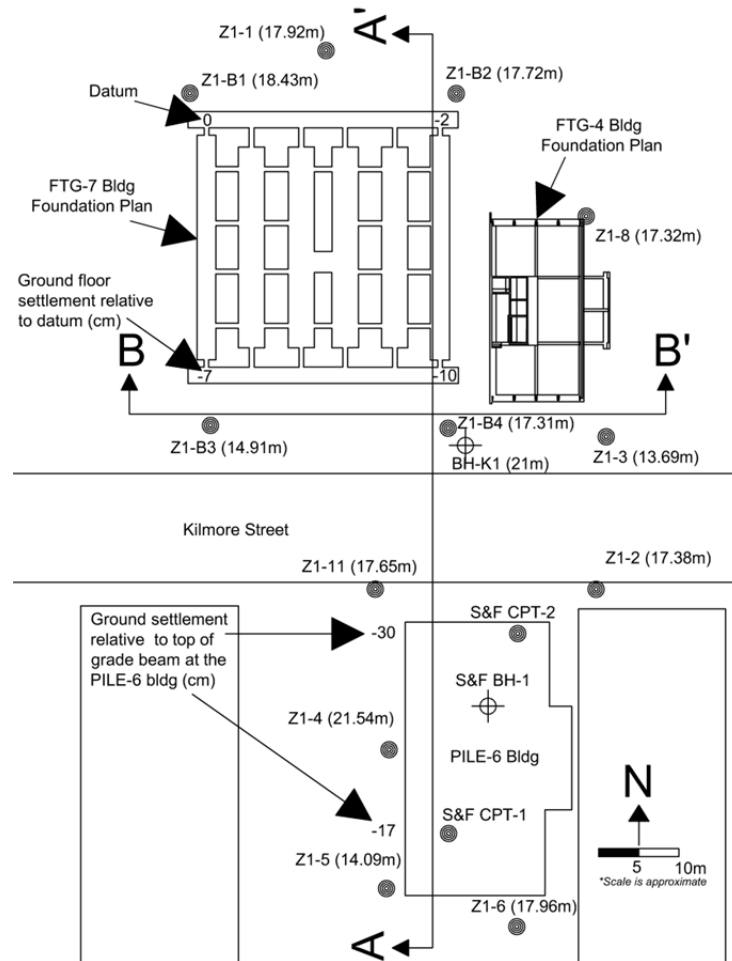
Figure 2.13. Zone 1 CPT locations, and shallow foundation plans for FTG-7 and FTG-4 buildings.

The FTG-7 Building, however, was damaged significantly with evidence of damage to the structural columns at the ground level. A floor level survey performed in March 2011 indicated approximately 10 cm of settlement of the SE corner of the building relative to the datum at its NW corner (Eliot Sinclair and Partners Ltd. 2011), and a subsequent building verticality survey (Beca 2011) confirmed the building was tilted to the S-SE. Relative settlements of the corners of the ground floor are indicated on Fig. 2.13. Post-liquefaction volumetric reconsolidation settlements from the Christchurch earthquake were calculated to be 25 cm at CPT Z1-B1, 28 cm at CPT Z1-B2, 24 cm at CPT Z1-B3, and 32 cm at CPT Z1-B4. Based on the observations of the settlement of the ground relative to the PILE-6 Building across the street, these estimates appear to be reasonable. However, the ground floor level survey indicated 7 cm of relative settlement of the SW corner (CPT Z1-B3) of the building to its NW corner (CPT Z1-B1). This differential settlement would not be estimated based on a direct comparison of the settlements calculated at CPT Z1-B1 and CPT Z1-B3.

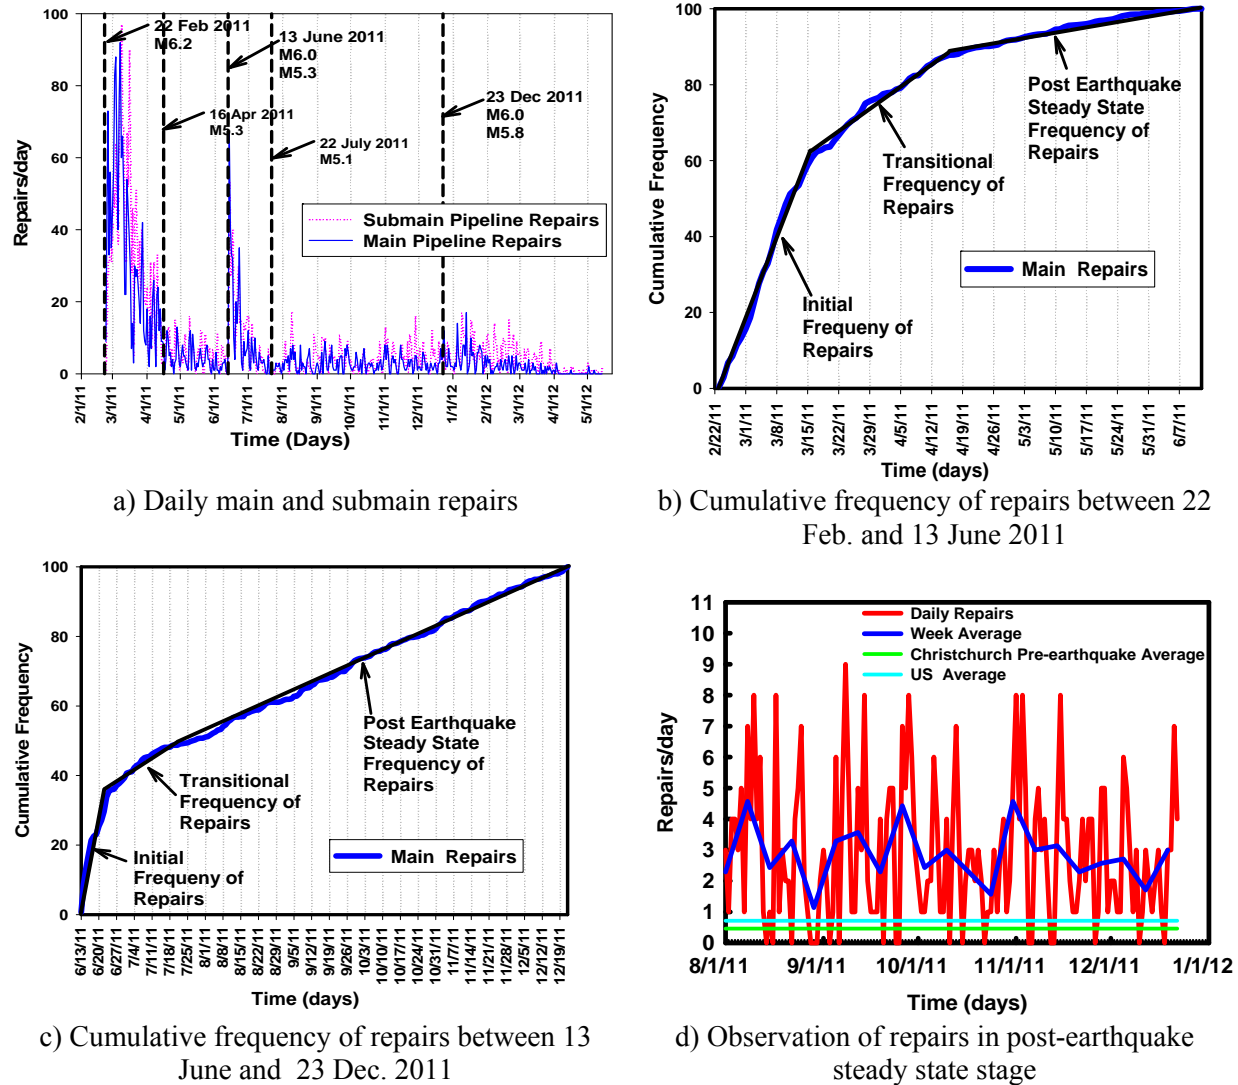
Figure 3.2d shows the daily and weekly average (expressed as a daily rate) repairs for the steady state conditions after the 13 June 2011 earthquake. For comparison, the Christchurch

average pre-earthquake (Christchurch City Council, 2006) and average US water distribution system (Bardet et al, 2010) daily repairs are shown in the figure. It can be seen that the steady state repair rate after large earthquakes in Christchurch is approximately 3 to 4 times greater than the rates not affected by prior earthquakes.

Figure 3.2. Water distribution repair characteristics with respect to time.

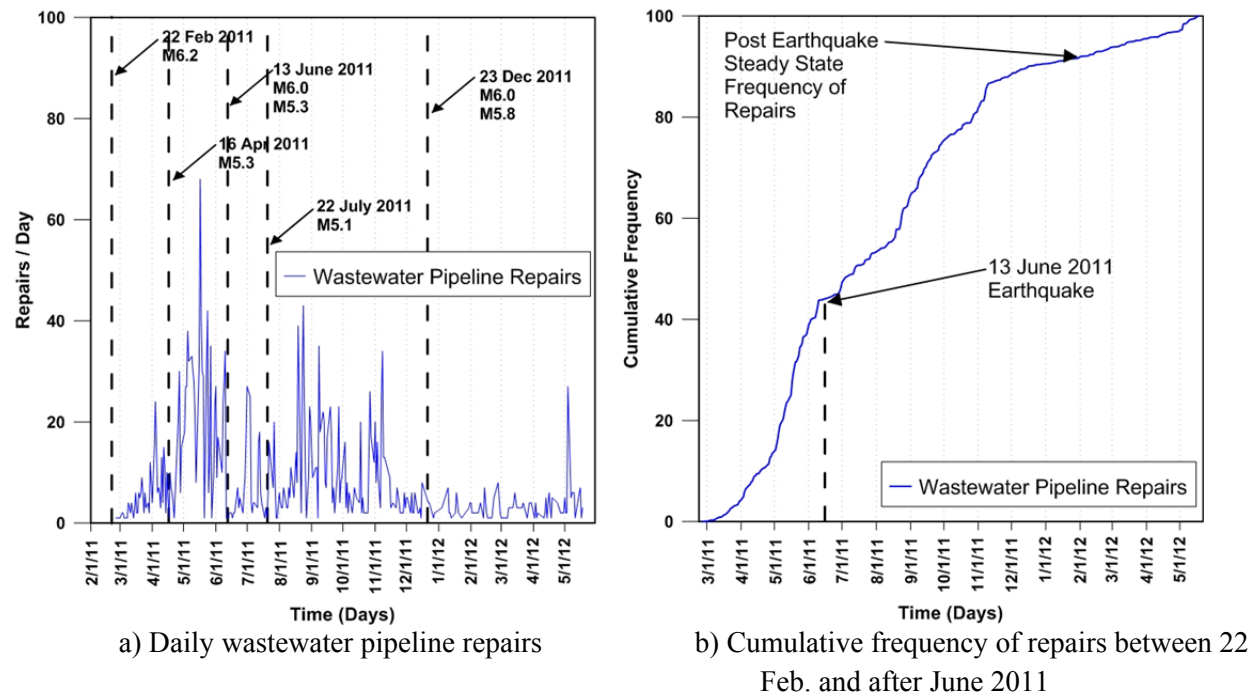
Figures 3.3a and 3.3b are plots similar to those in Figs. 3.2a through 3.2c from repair records provided by SCIRT for wastewater pipelines for Feb. 23, 2011 to May 14, 2012. Figure 3.3a presents the daily repairs for wastewater pipelines as a function of time. Figure 3.3b shows the cumulative frequency of repairs for reinstatement of services, derived from Fig. 3.3a. Similar to the trends in Figs. 3.2b and 3.2c there is a steady state of repairs that is used to identify the end of repair activities directly related to the 22 Feb. and 13 June 2011 earthquakes.

In contrast to the trend in Fig. 3.2b, significant numbers of repairs were not recorded until 3 to 4 weeks after the 22 Feb. 2011 earthquake. This delay is related to the repair efforts that were first concentrated on the water supply, leaving a smaller work force to attend to the wastewater system until substantive water supply repairs were achieved. Because wastewater system repairs

were preceded by removal of debris washed into damaged pipes and closed circuit television (CCTV) inspection of the lines, the rate of repairs increased slowly at first. As can be seen in Fig. 3.3b, the 13 June 2011 earthquake occurred before convergence to a steady state. In contrast to the water supply, it is not possible to identify all wastewater repairs caused by the 22 Feb. 2011 earthquake because many lines damaged by that earthquake had not been repaired when the 13 June 2011 earthquake occurred. It was therefore necessary to develop an averaging procedure for both earthquakes to evaluate wastewater pipeline RRs relative to PGD, as described later in the section.

Figure 3.3. Wastewater distribution repair characteristics with respect to time.

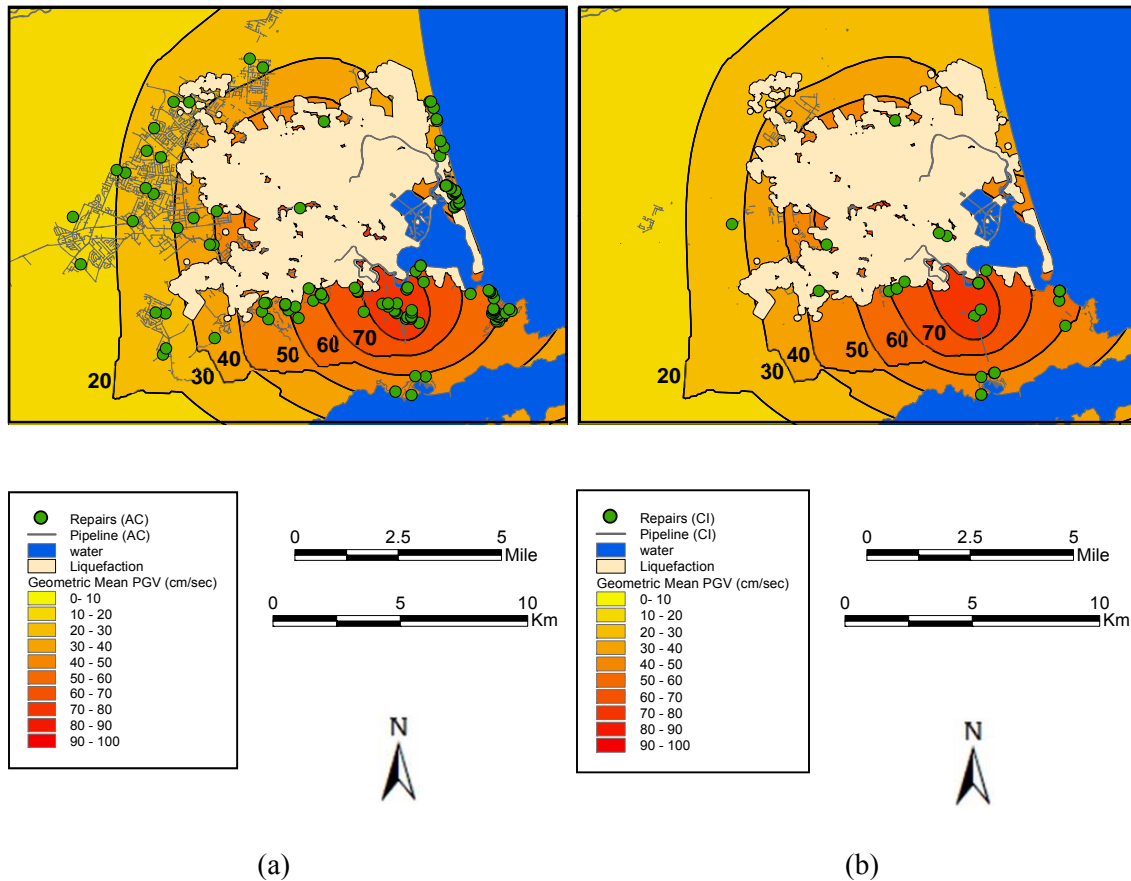
Figure 3.4 shows the zones of observed liquefaction, water supply pipelines, repairs outside liquefaction zones, and contours of GMPGV for the 22 Feb. 2011 earthquake, pertaining to AC and CI distribution mains, respectively. The areas of observed liquefaction are shown in white,

Figure 3.4. a) 22 Feb. 2011 earthquake AC pipeline layout and repairs; map of GMPGV is the background. b) 22 Feb. 2011 earthquake CI pipeline layout and repairs; map of GMPGV is the background.

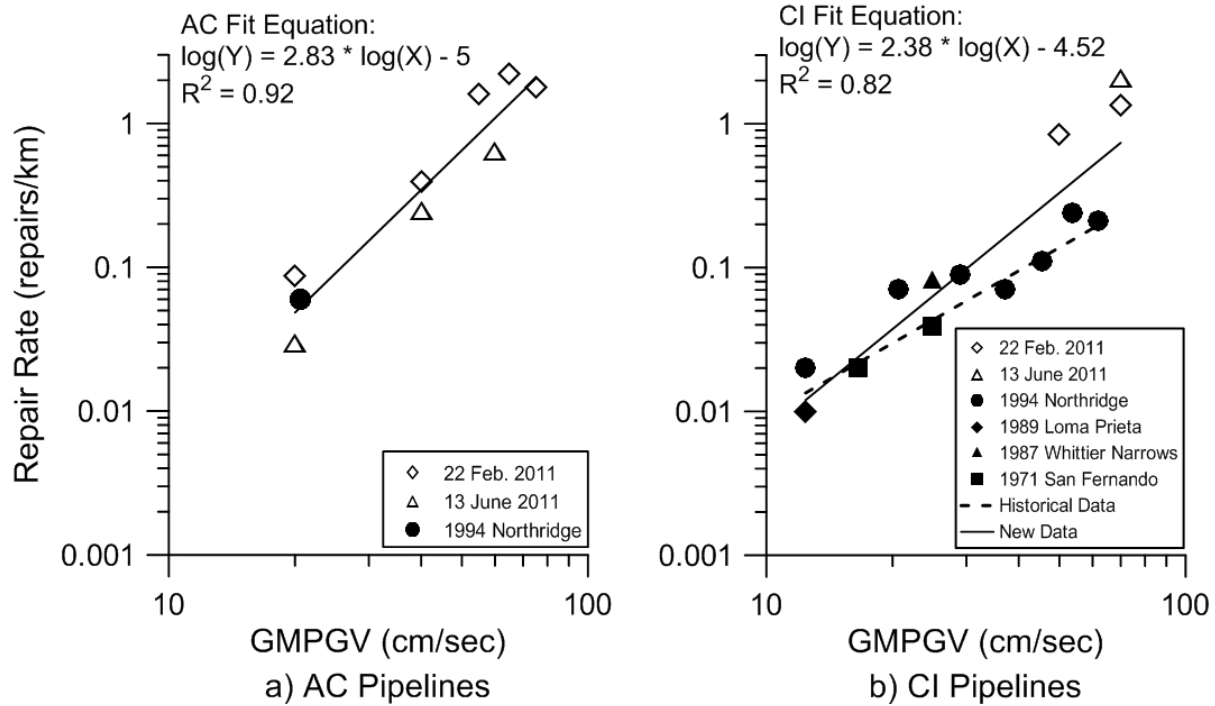
Using the Eqn. 3.4 screening criteria, RRs for AC pipelines and various GMPGVs were obtained for the 22 Feb. and 13 June 2011 events, and combined with similar data reported by Jeon (2002) for AC pipelines damaged by the 1994 Northridge earthquake. The results are presented in Fig. 3.5a. The linear regression for all earthquakes is statistically robust with $r^2 = 0.92$ and balanced distribution of residuals. Using similar techniques for CI pipelines, three data points for Christchurch are combined with worldwide data reported by Jeon and O'Rourke

(2005) to develop the linear regression in Fig. 3.5b. The Christchurch data are for relatively high GMPGVs, and plot slightly above the linear trend for previous earthquakes.

Figure 3.5. Repair rate vs. GMPGV for a) AC pipelines and b) CI pipelines.

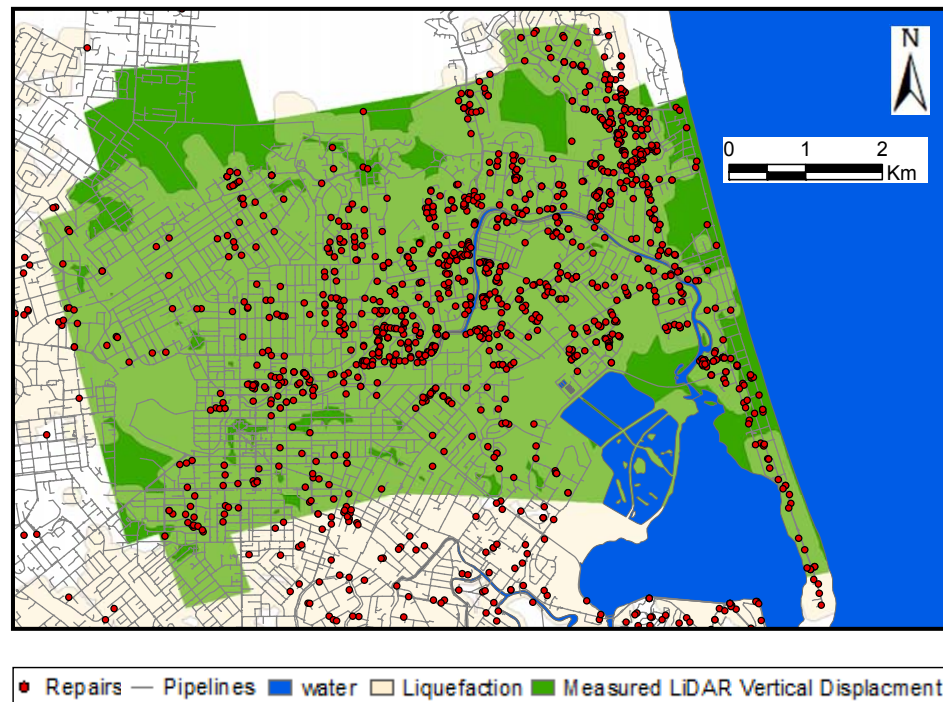
Figure 3.6 shows the area where vertical ground surface movement was calculated based on the overlapping area of the pre and post earthquake LIDAR survey extents for the 22 Feb. 2011 earthquake superimposed on the areas of observed liquefaction. The pipeline system and repair locations are also presented in the figure. Correlations of RR with differential vertical movement were developed for the intersection of the areas of observed liquefaction and the areas with calculated vertical ground surface movement, as illustrated in the figure.

Figure 3.6. Coverage of liquefaction and measured LiDAR vertical displacement associated with pipeline distribution and repairs for 22 Feb. 2011 earthquake.

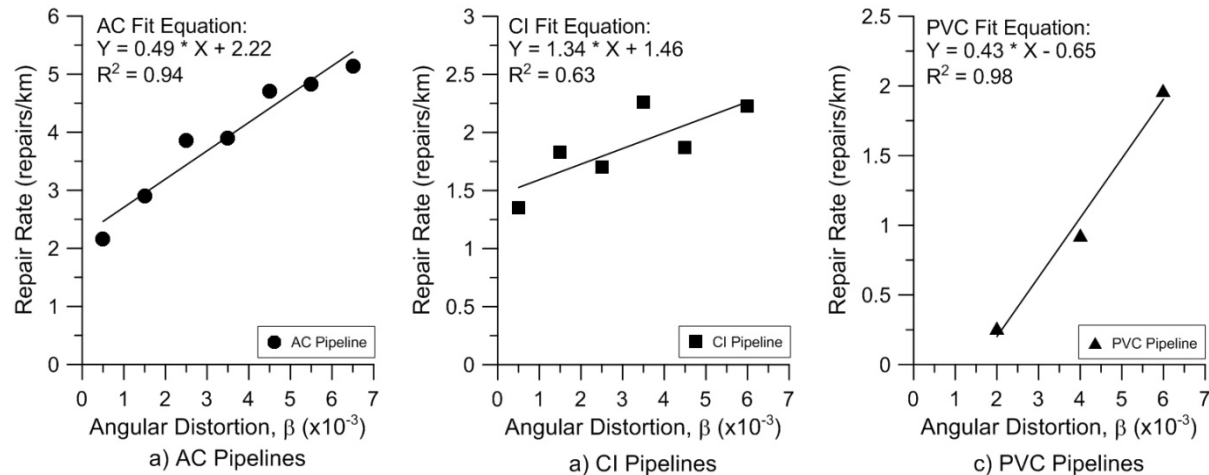
The linear regressions and equations are shown in Figs. 3.7 and 3.8 for water and wastewater pipelines, respectively. Sufficient RR data for AC, CI, and PVC water pipelines that passed the screening process were available to develop the regressions in Fig. 3.7. Likewise, sufficient data for EW, RCRR, and CONC wastewater pipelines that passed the screening process were available to develop the regressions in Fig. 3.8. Pipeline damage is related to the combined effects of differential vertical and lateral ground surface movement such that damage can occur in response to lateral strain when $\beta = 0$, as shown in the regressions.

Figure 3.7. Repair rate vs. angular distortion of AC, CI, and PVC water pipelines.

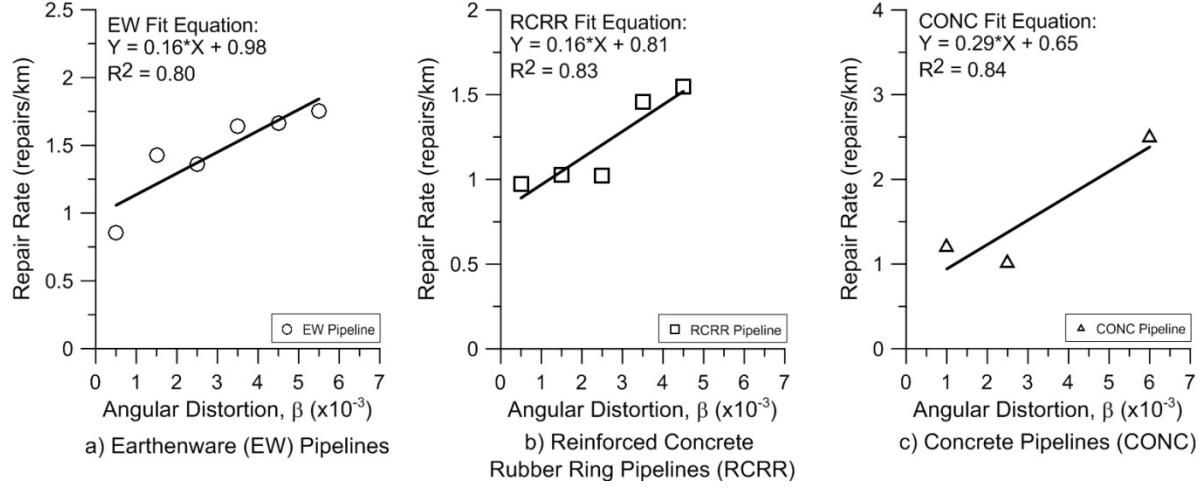
Figure 3.8. Repair rate vs. angular distortion of EW, RCRR, and CONC wastewater pipelines.

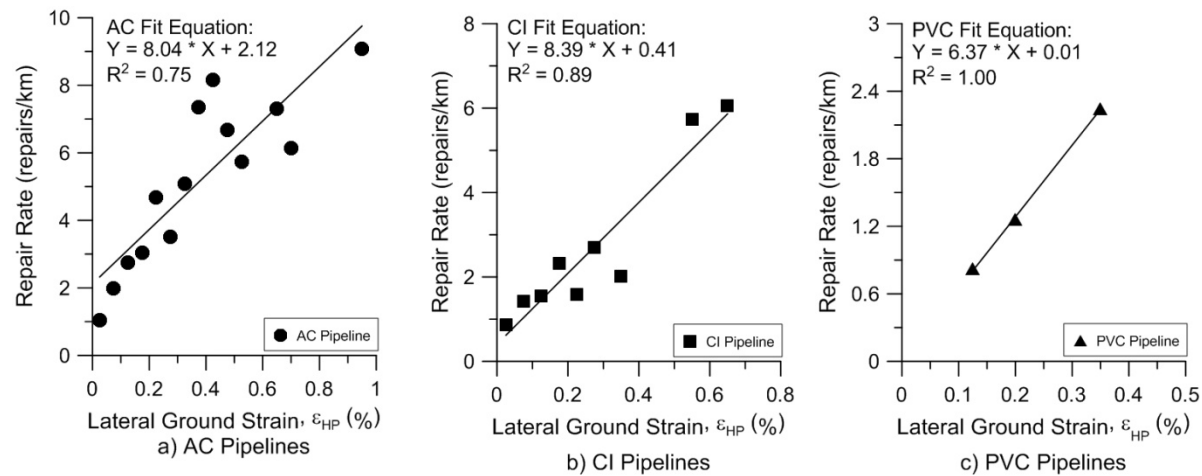
Figures 3.10 and 3.11 present RR vs. lateral ground strain linear regressions for water and wastewater pipelines, respectively. The lateral ground strain is the maximum absolute value of the ground strain, ε_{HP} , given by Eqn. 3.6. The RRs were screened following procedures similar to those used with β , as previously described. Average RRs were determined following the same approach used for wastewater pipelines above to develop correlations with β .

There were sufficient RR data passing the screening criteria for AC, CI, and PVC water pipelines and EW and CONC wastewater pipelines to develop linear regressions. The regression results show a strong correlation between pipeline damage and lateral ground strains, as indicated by the relatively high r-squared values. The RRs plotted in Figs. 3.10 and 3.11 also reflect damage from differential settlement that can occur when $\varepsilon_{HP} = 0$, as shown in the regressions.

Figure 3.10. Repair rate vs. lateral ground strain correlations for AC, CI, and PVC water pipelines.

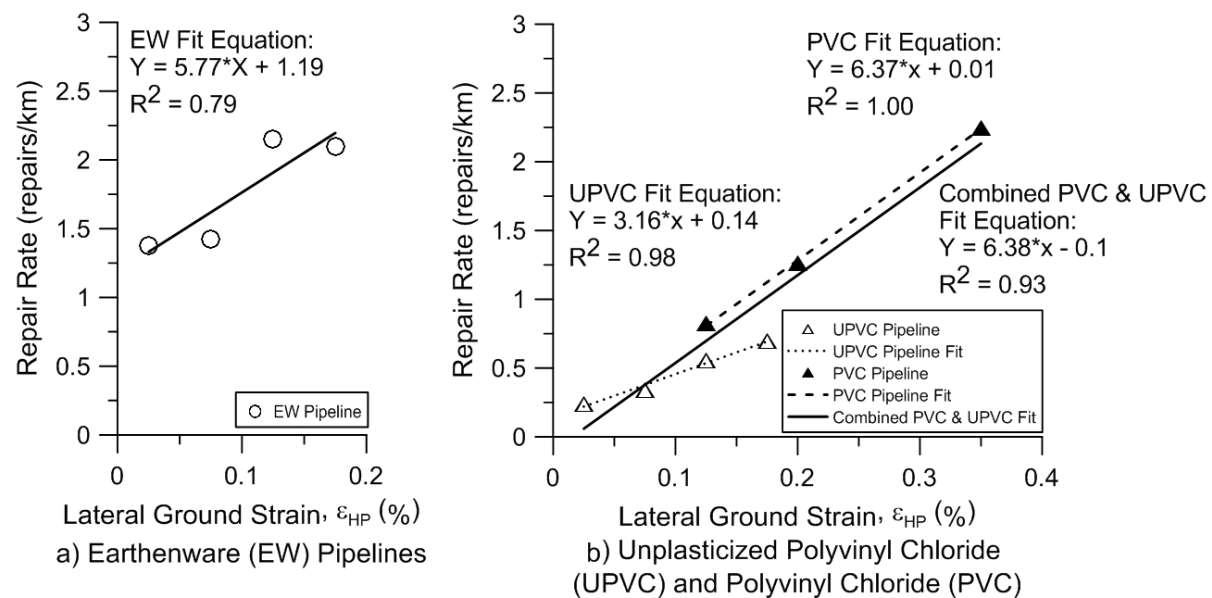
Figure 3.11. Repair rate vs. lateral ground strain correlations for EW, PVC and UPVC wastewater pipelines.

In Fig. 3.11b linear regressions for PVC, UPV and the combined data for both pipeline types are shown. Although the PVC water and UPVC wastewater pipelines differ slightly with respect to PVC additives and pipe wall thickness, they are similar with respect to strength and mechanical properties. Moreover, they are equipped with joints having similar geometries, insertion depths, and gaskets. As shown in the figure, the combined data regression provides a good fit for both data sets with high r-squared.

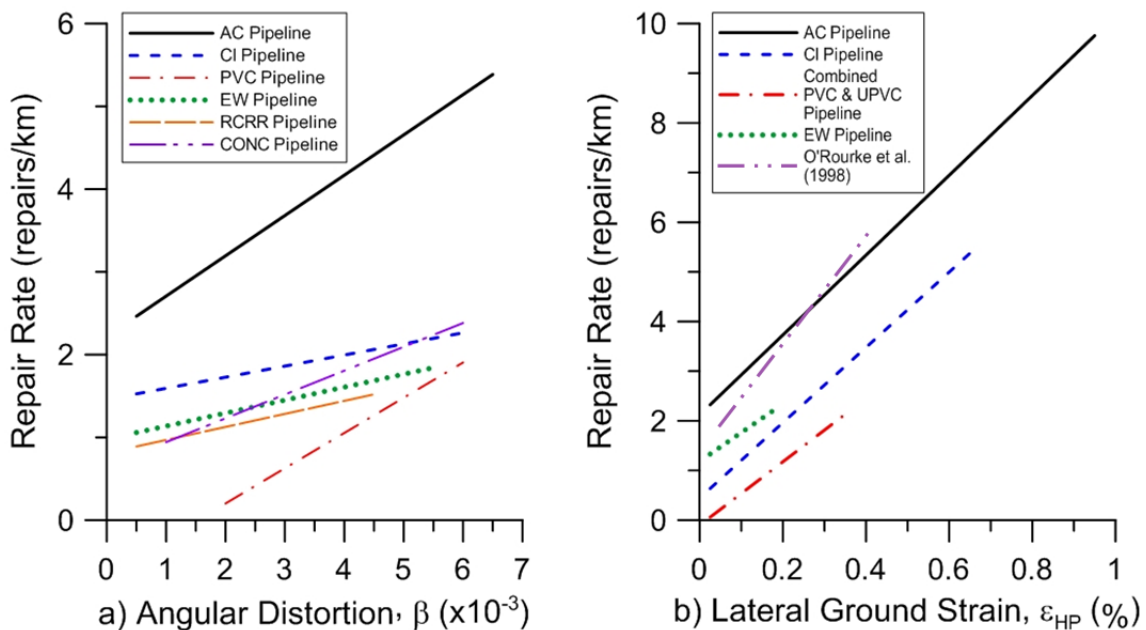
Figure 3.12a compares the regression of RR vs. β for AC, CI, and PVC water pipelines and EW, RCRR, and CONC wastewater pipelines. The figure shows that AC pipelines are especially vulnerable to differential vertical movement, with RR as much as 2 to 3 times higher than that for CI pipelines at comparable levels of β . This vulnerability is attributable in part to the use of a relatively weak AC collar to join adjacent lengths of pipe. This collar is susceptible to cracking in response to relative rotation caused by differential settlement. CI pipelines, in contrast, have additional wall thickness at the bell end of bell-and-spigot joints. Such joints are thus more resistant to stress concentrations associated with relative rotation. The fragilities of CI, EW, RCRR, and CONC pipelines are comparable, with trend lines clustered between those for AC and PVC. The PVC RRs are approximately one fourth those of the AC pipelines, representing the greatest spread in RR levels for similar β of the

Figure 3.12. Comparison of repair rate vs. angular distortion and lateral strain for different pipe types.

pipelines under comparison. At very high levels of differential settlement the RRs for PVC pipelines converge with those of CI, EW, CONC, and RCRR pipelines.

Figure 3.12b compares the pipeline damage correlations with lateral ground strain for AC, CI, EW, PVC and UPVC pipelines. Asbestos cement pipelines have the highest RR per level of ground strain, which is approximately 3 to 5 times as high at strains exceeding 0.05 % as that for PVC pipelines. Cast iron and EW pipeline RRs plot between the trends for AC and PVC pipelines. The combined PVC and UPVC regression, as described with respect to Fig. 3.11b, is plotted in Fig. 3.12b. There is no clear convergence of damage levels for AC, EW, CI, and PVC within the range of lateral strains covered by this study.

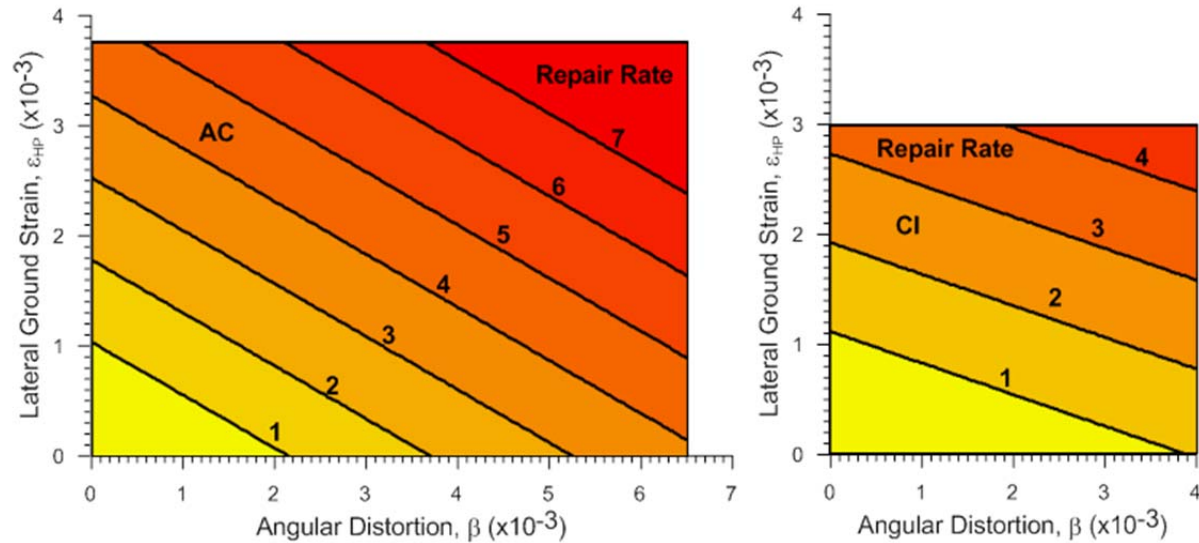
In a similar manner, a damage assessment approach for AC and CI water pipelines was developed for the 22 Feb. 2011 earthquake by correlating RR with both lateral ground strain, ϵ_{HP} , and angular distortion, β . The correlation was performed by counting repairs and lengths of AC and CI pipelines associated with ϵ_{HP} and β intervals of 1×10^{-3} . Sampling for specific combinations of ϵ_{HP} and β results in a relatively small length for each combination. To provide a sufficient number of data points for robust interpolation, the screening criteria associated with Eqn. 3.4 were relaxed to reflect a confidence of approximately 85% and 70% for AC and CI pipelines, respectively. The corresponding RR values were plotted in a graph of ϵ_{HP} vs. β , and the global polynomial interpolation method in ArcGIS software was used to produce RR contours as illustrated in Fig. 3.13.

Figure 3.13. Repair rate vs lateral strain, and angular distortion for AC and CI pipelines.

As indicated in Table 3.1 there were nearly four times as many repairs for AC compared to CI pipelines in areas of observed liquefaction, thus providing a more extensive database for sampling relative to ϵ_{HP} and β combinations. As a result, it was possible to pass the sampling criteria for more ϵ_{HP} and β combinations with AC than CI pipelines, which is reflected in the relative size of the charts.

The higher vulnerability of AC pipelines is indicated by the charts, which show lower thresholds of ϵ_{HP} and β for a given RR compared to CI pipelines. Consistent with Figure 3.12a, AC pipelines are especially sensitive to β , with β thresholds for a given RR approximately one half those for CI pipelines.

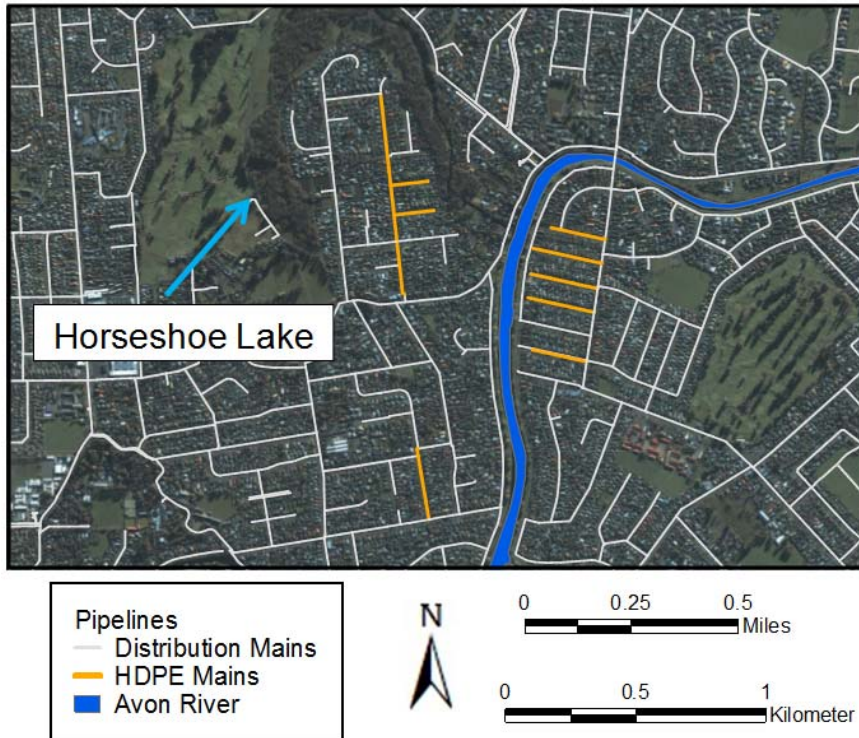
After the 4 Sept. 2013 earthquake high and medium density polyethylene (HDPE and MDPE) water mains were used to replace damaged portions of the distribution system in the Burwood and Dallington areas of Christchurch. Figure 3.15 shows the location of these mains, which represent a total length of approximately 2.6 km. No damage was observed in these HDPE and MDPE pipelines after both the 22 Feb. and 13 June 2011 earthquakes, even though this area was subjected to severe liquefaction and lateral spreading of approximately 2 m after both earthquakes.

This deployment of highly ductile pipelines represents the first documented case where HDPE and MDPE pipelines were successfully installed explicitly to resist large liquefaction-induced PGD. On the basis of this experience, HDPE and MDPE mains are being used to replace damaged and vulnerable pipelines in areas vulnerable to soil liquefaction within the Christchurch distribution network, thereby improving performance in future earthquakes. The distinction between HDPE and MDPE is made on the basis of small changes in molecular weight. The yield stress and modulus of MDPE are approximately 80% of those for HDPE, and the ability to sustain bending, tension, and compression in response to ground movements are comparable for the two types of polyethylene pipelines (Stewart, et al, 2000).

Figure 3.15. Location of HDPE pipelines installed after the Darfield earthquake.
