FINAL TECHNICAL REPORT

**DETAILED MAPPING OF THE NORTHERN SAN ANDREAS FAULT USING LIDAR
IMAGERY**

Collaborative Research with Judith Zachariasen
and USGS Western Region Earthquake Hazards Team

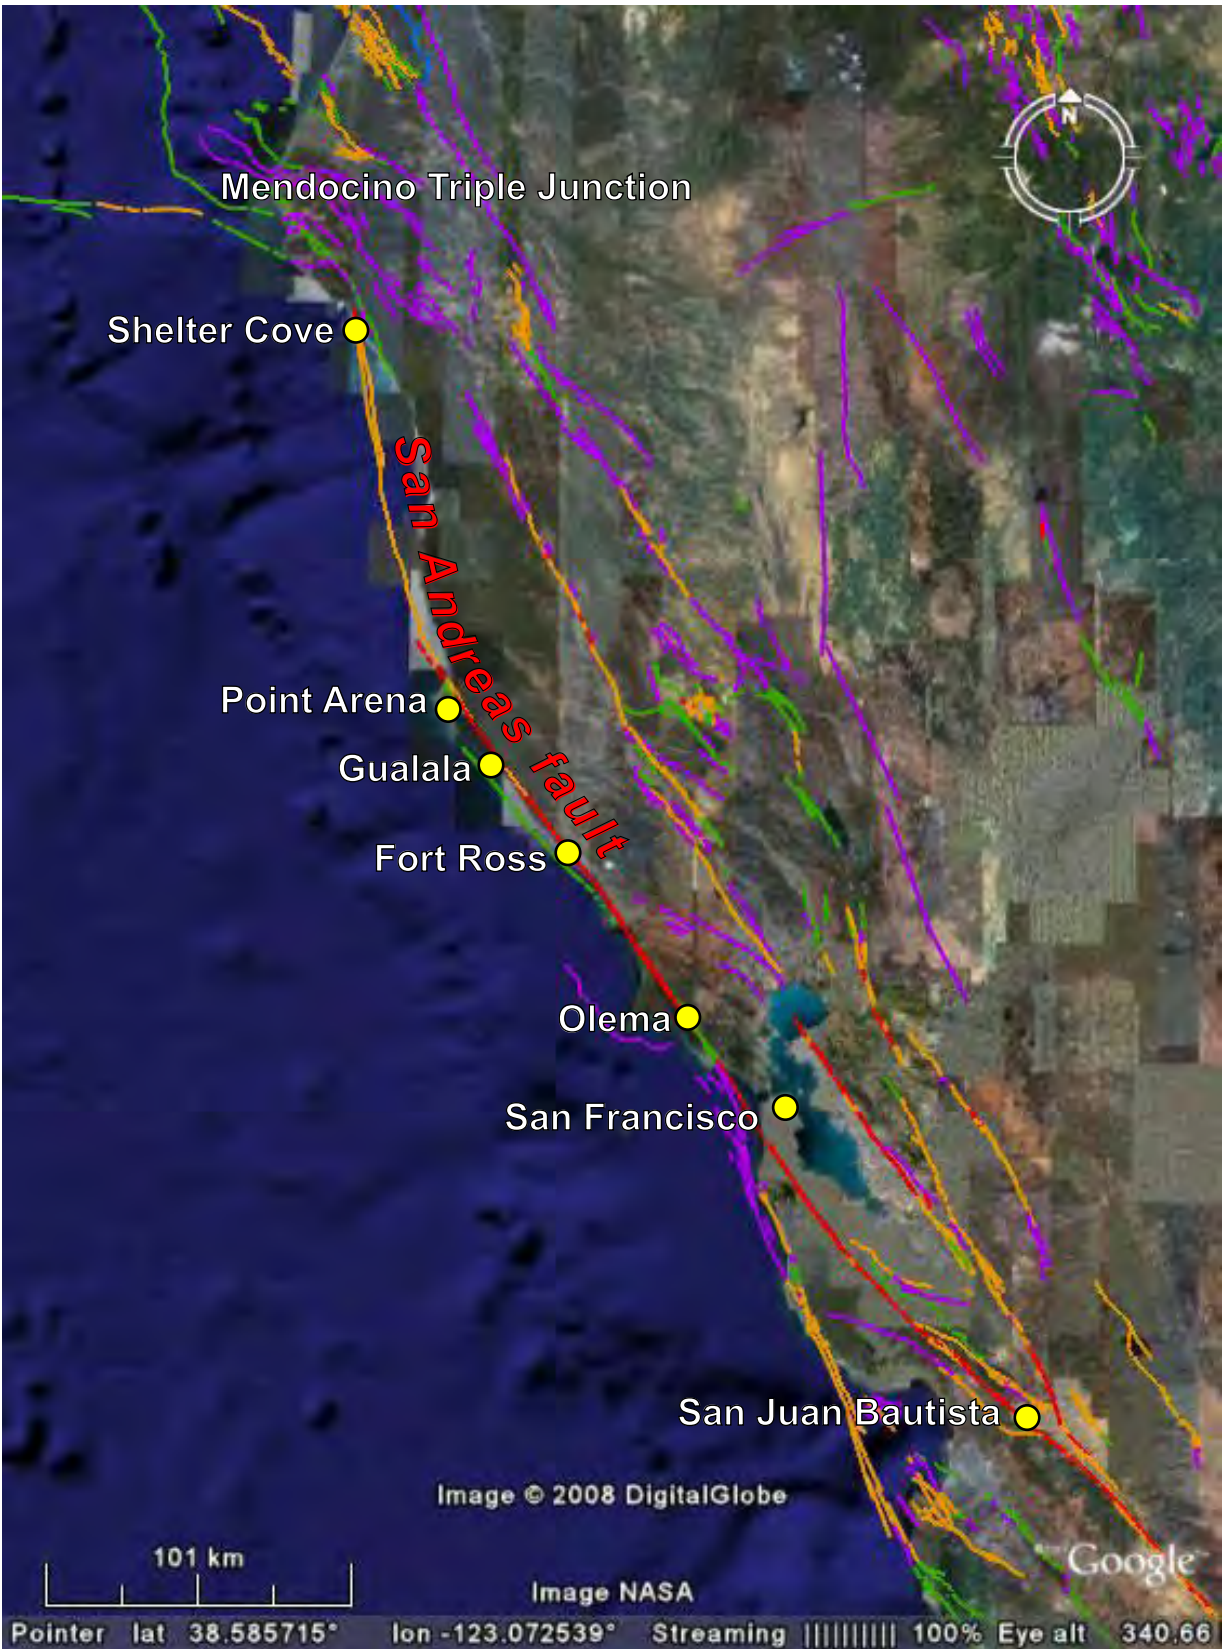
Figure 1. Map of northern California and Quaternary faults included in the U.S. Geological Survey Quaternary fault and fold database (USGS/CGS, 2006). Base image from Google Earth.

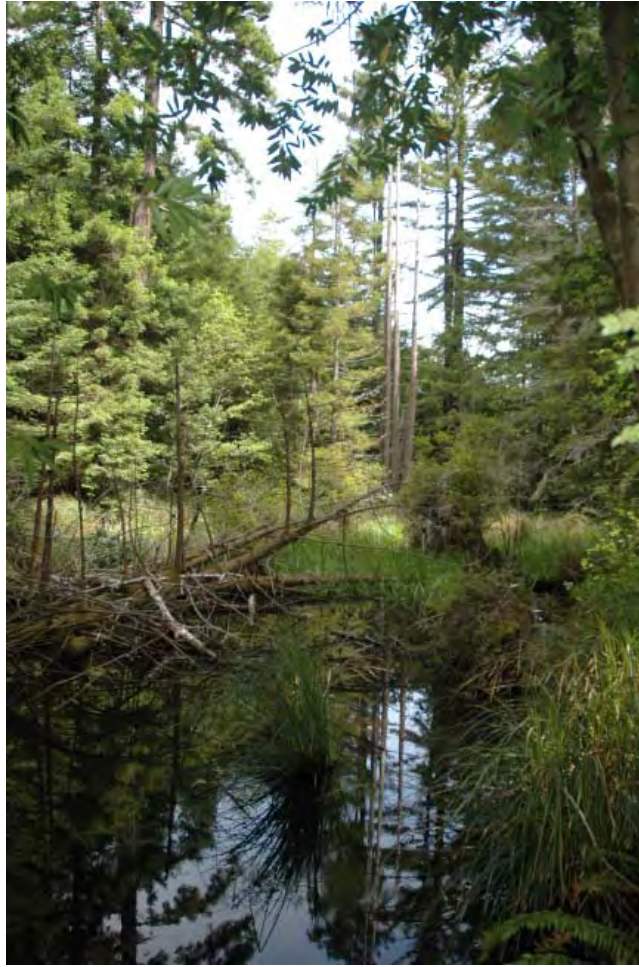
Figure 7. Photograph of pond along fault with drowned trees. Site 134, Figure 6b. View to the northwest.

Along the rest of this section, the fault continues as one primary trace with smaller secondary subparallel traces, and to the southeast becomes more discontinuous with subparallel and en echelon strands. Again, numerous and extensive ponds delineate the fault along much of its length; to the southeast steep, predominantly west-facing scarps as high as 15 m characterize the fault. We also observed right-laterally offset, deflected and beheaded streams (e.g. 107) and abandoned channels (e.g. 74, 100, 101, 135). At the southeastern end of this section, a large pond fills a depression along the fault (129, 133, 134). Numerous drowned trees occupy the pond, testifying to deepening and expansion of the pond since growth of the trees (Figure 7).

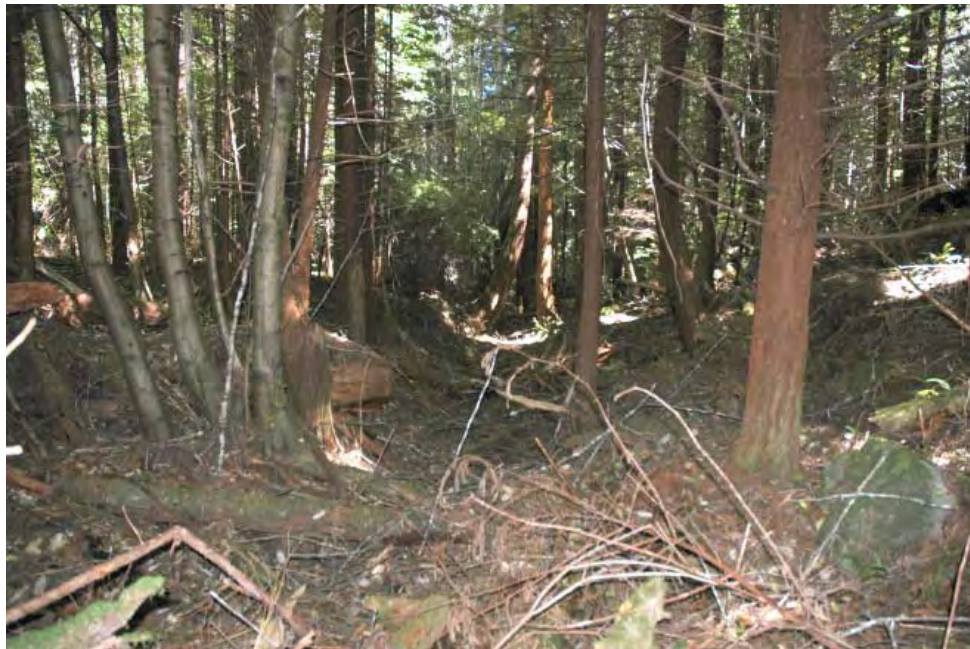
Figure 8. Linear valley along fault. Site 182, Figure 6c. View to the southeast.

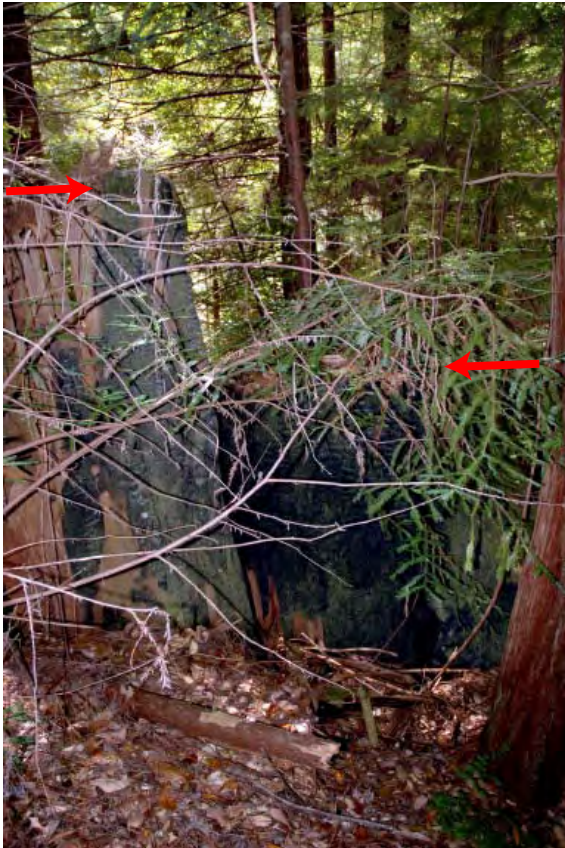
Figure 9a. Burned and twice-offset logged redwood stump. Red arrows marked logged top surface of stump and illustrate vertical separation of two sides. View to south.

On the western trace, located on the flanks of the west-facing scarp, a logged redwood stump (201) may have been offset in both the 1906 earthquake and the penultimate event. The characteristics of the sawing indicate that it was logged in the 19th century. The stump is offset both horizontally and vertically, with the flat logged top surface showing several tens of centimeters of down-to-the-west vertical separation; it has also been offset right-laterally 1-2 meters (Figure 9a,b). Between the two separated pieces of stump, we can precisely match well-defined, curving "puzzle pieces" of wood; these pieces show 65 cm of sub-horizontal right-lateral displacement, with much less of a component of vertical separation than the stump itself (Figure 9b,c). In addition, the stump has been burned; most of the interior surfaces of the split stump has burned, but not the displaced puzzle pieces, suggesting the burn occurred prior to the displacement of the puzzle pieces. We interpret this stump as having possibly experienced two offset events. The earlier event split the tree but did not kill it or completely break it in two throughout; rather it continued to grow with a split basal trunk. In the 19th century, the tree was cut down, with each piece of trunk individually logged. The two people required to saw the trunk by hand would have stood at the same level relative to the base of the tree while cutting each part. Since the tree was growing on a scarp, the east part was on higher ground than the lower, so the upper sawn surface was thus probably also higher on the eastern trunk. Then, in 1906, the now logged stump was again offset, with about 65 cm of horizontal and negligible vertical displacement. This scenario accounts for the mismatch in displacement between the stumps and the puzzle pieces and explains the greater component of vertical separation of the stumps' logged surfaces. Further study of this stump could provide information on the timing of the penultimate event.

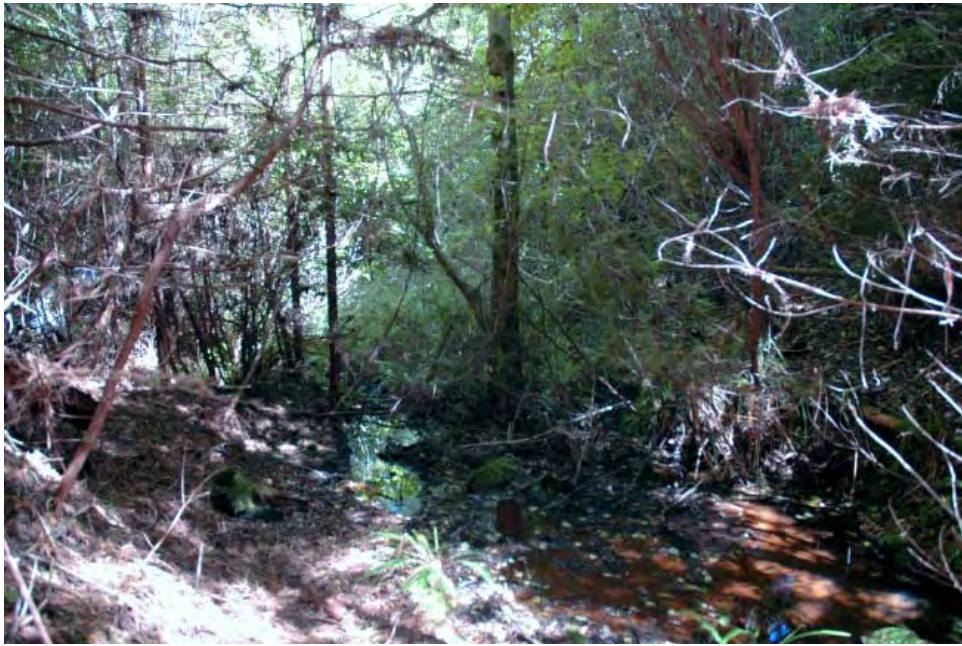
Figure 10. Linear valley with small pond. Site 259, Figure 6d. View to the northwest

Throughout this section the fault comprises two or three traces. Along most of their extent, all traces occupy narrow linear valleys flanked by west-facing scarps (Figure 10). The fault is not evident as it crosses a steep canyon at about 38°52'30" but is otherwise well defined until it enters and occupies a deep active drainage that has captured the outflow of several tributary streams. This drainage marks the end of our southern section and the boundary between the mapping areas of this study and Koehler and others (2005). This section also includes one large pond (272, 276) containing numerous drowned redwood trees in growth position. The outlet of this pond is presently at the east side of the pond about half way along its extent (274). The water exits through a broad shallow gap in a west-facing scarp, and flows without a defined across the road; at the far end of the road, the water flows out a defined channel. A few meters south of the outflow, bedrock is exposed in the road; if bedrock floors the outflow as well, there may be no

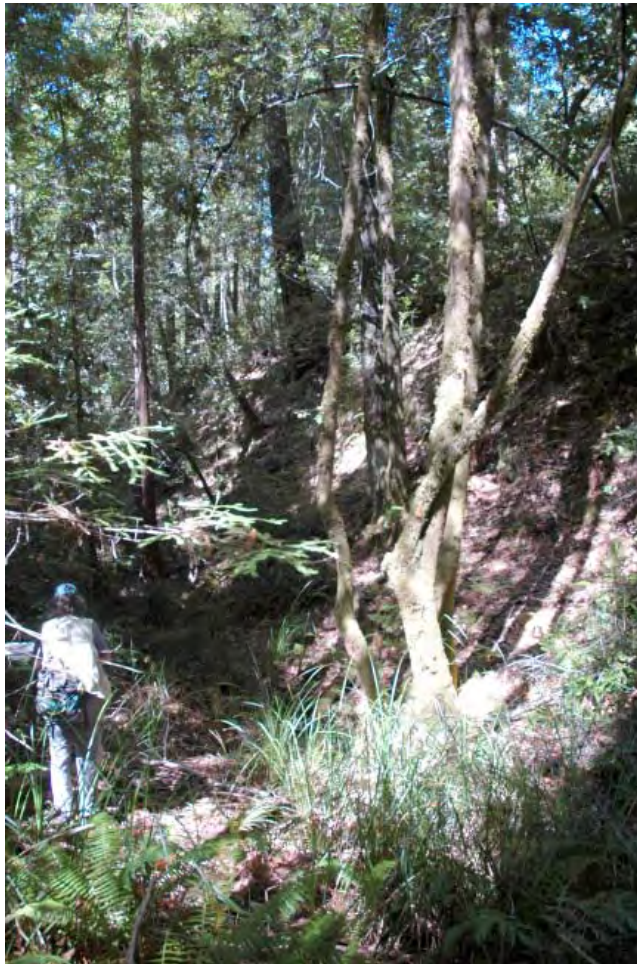
Figure 11. Linear valley with west-facing scarp that reaches 10 m in height. Site 327, Figure 6e. View to the northwest.

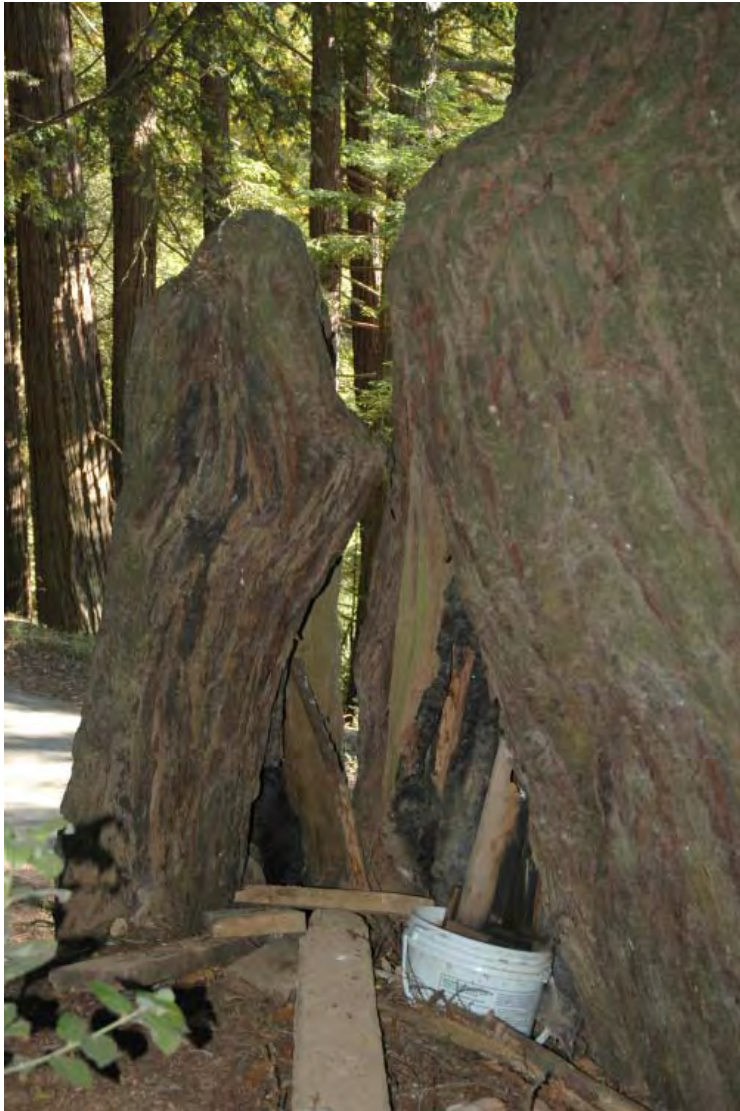
Figure 12. Tree on road at Plantation farm offset in 1906 earthquake. Site 370, Figure 6e. View to the south.

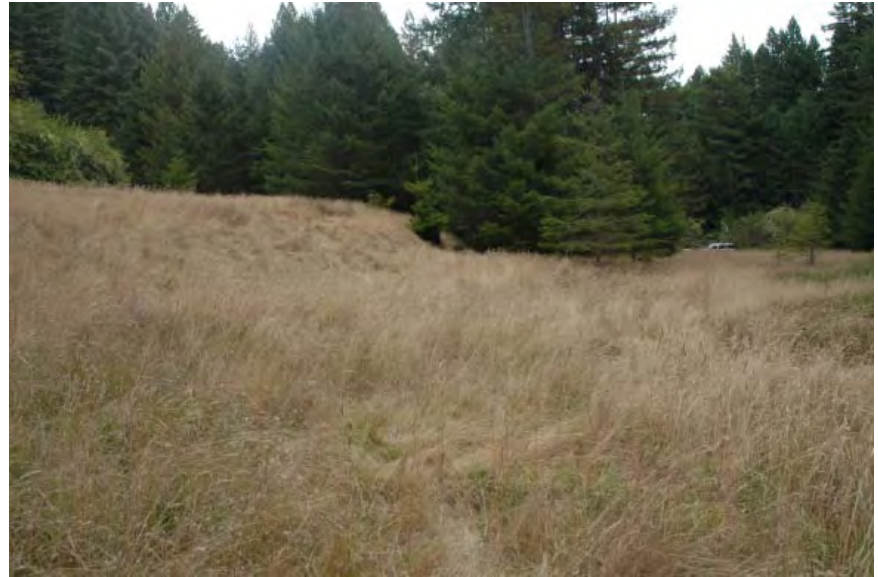
Figure 13. West-facing scarp at Buttermore Ranch. Site 614, Figure 6g. View to the southeast.

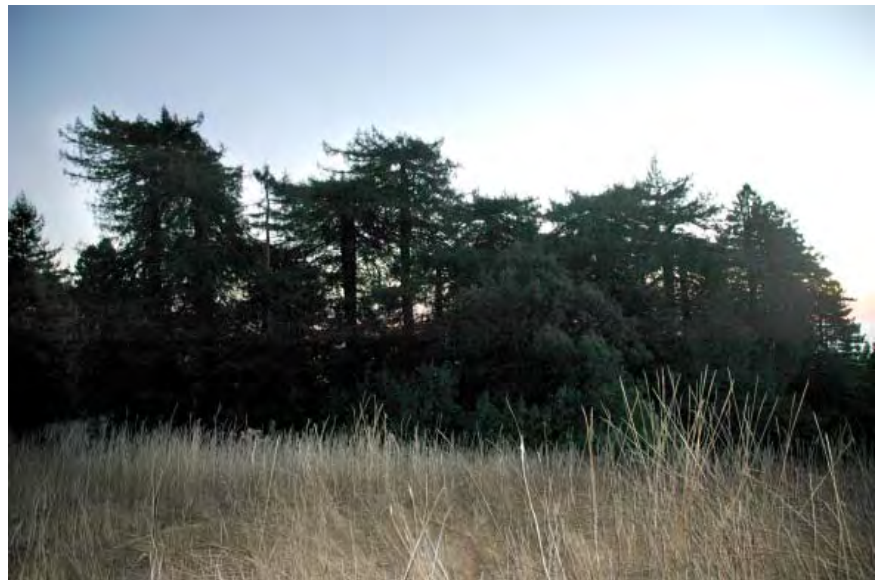
Figure 14. Trees damaged in 1906 earthquake. Near Fort Ross Road. Site 653, Figure 6h. View to the southwest.

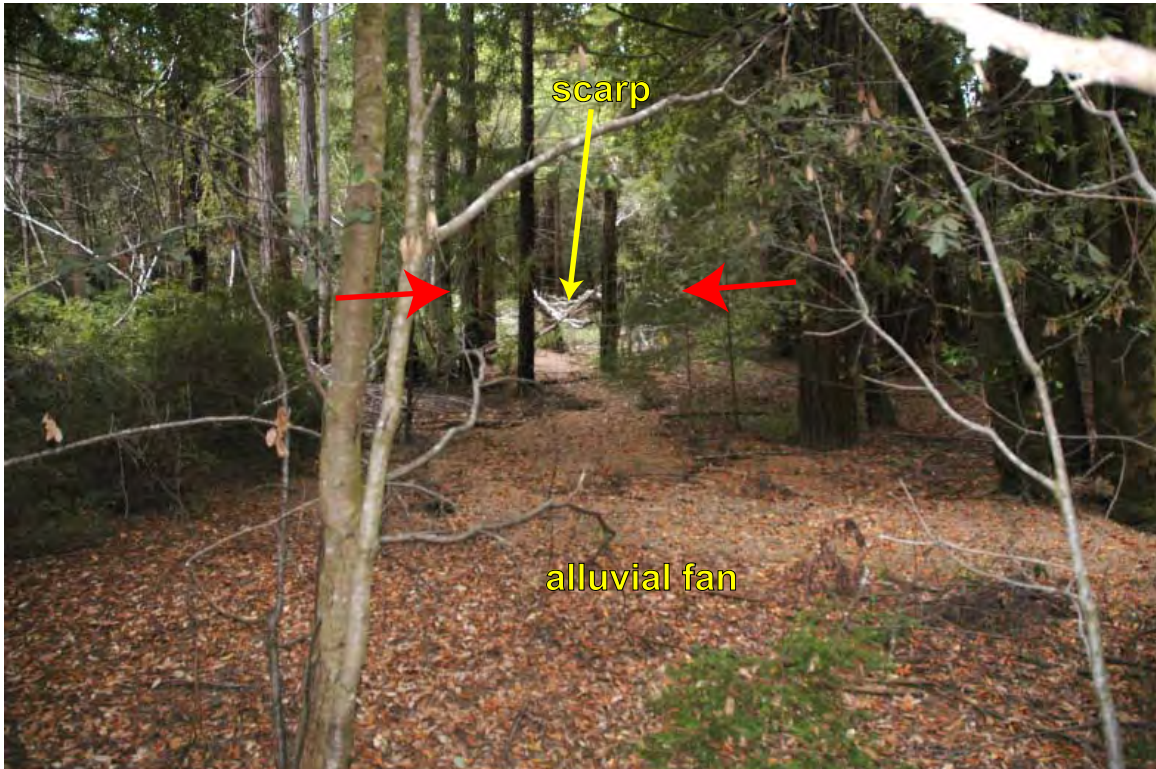
Figure 16. Possible trench site where Holocene alluvial fan material is deposited against a east-facing fault scarp in Salt Point State Park. Site 467, Figure 6f. View to the west. Red arrows mark the fault; fellow arrow points to the buried scarp.

One promising site (467) is located on Salt Point State Park land at about latitude 38°34'00". The fault is in one primary traces here; a second en echelon trace is evident just to the south, and there are two short, questionable lineaments to the west, but this strand probably has been carrying most of the slip. The fault emerges from a linear valley into a broad open area. The fault here is marked by a small east-facing scarp, which is partially buried in alluvium that has been deposited against the scarp (Figure 16). The alluvium is young and clearly buries the base of the trees that grow within the fan to the east of the scarp, suggesting a relatively high sedimentation rate. The fan material exposed at the surface comprises pebble to small cobble gravel and sand, which should provide well-stratified deposits appropriate for interpreting stratigraphic and
