Final Technical Report

Evaluating the Repeatability of Lateral Spreading

Prepared for:
U.S. Geological Survey
National Earthquake Hazards Reduction Program
Award No. 03HQGR0075

Prepared by:
William Lettis & Associates, Inc.
1777 Botelho Drive, Suite 262
Walnut Creek, CA 94596

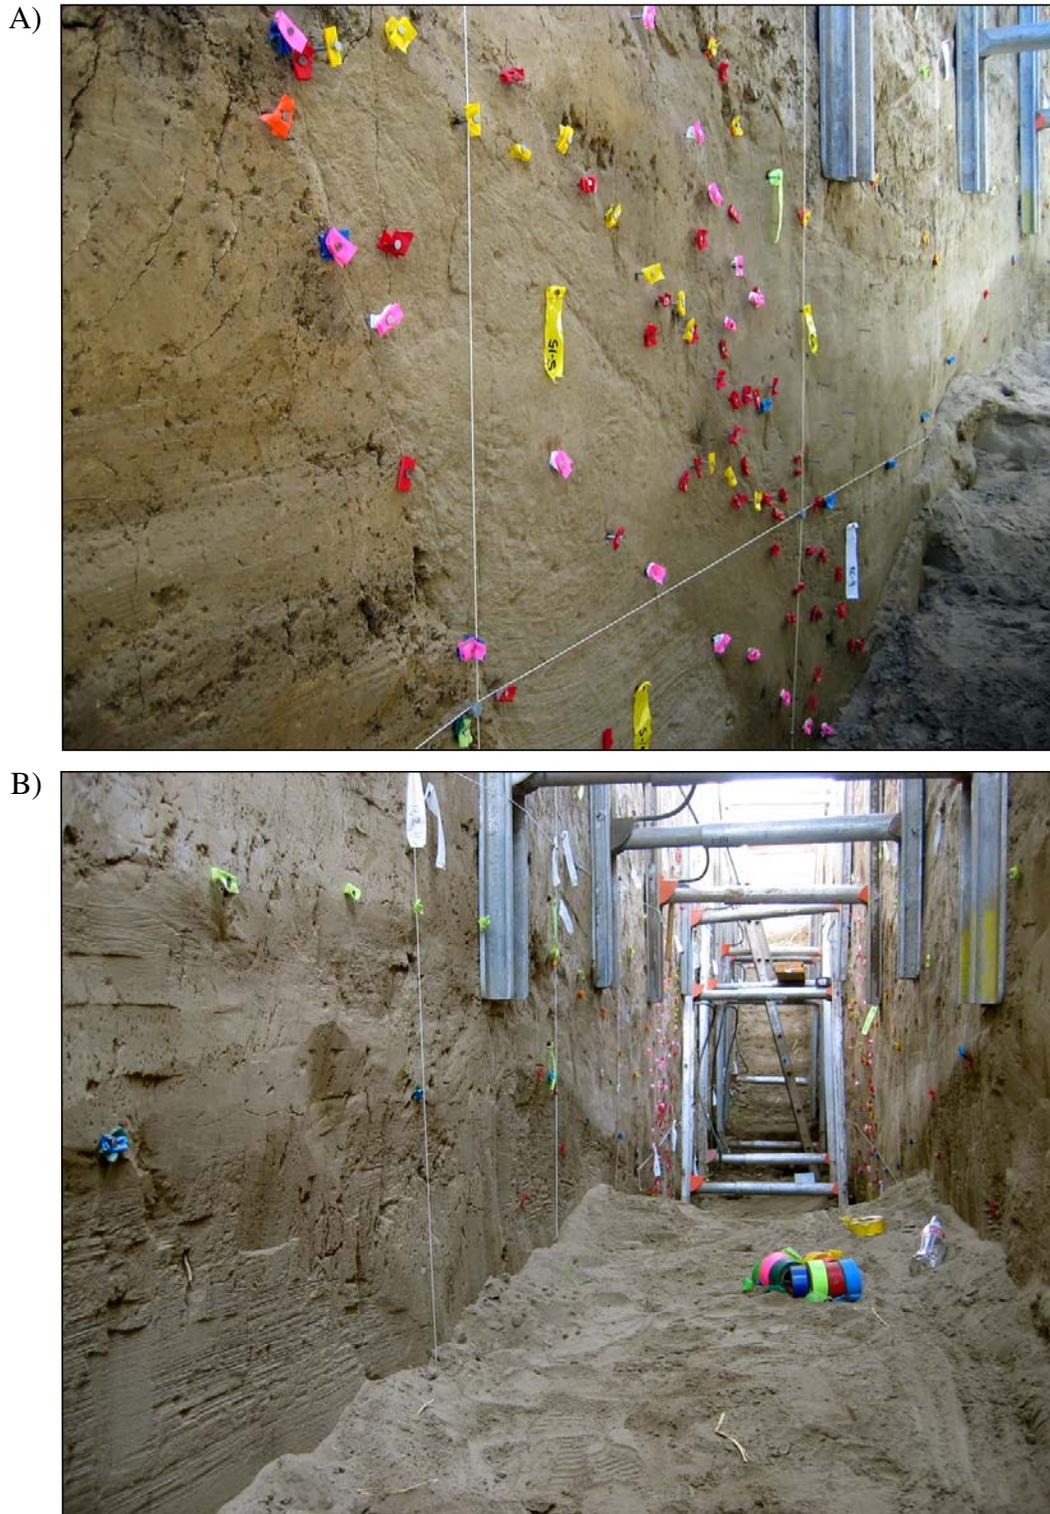
Figure 3. A) View of the west wall, trench T-1, Miller Farms site, towards the north. Mid-Holocene floodplain deposits at the left side of the photo are juxtaposed against younger point-bar, channel, and proximal levee deposits at the right end of the photo. A zone of clastic dikes (bounded by pink and yellow flags) and normal faults (red flags) provides evidence of past lateral spreading (see Plate 2). String grid is 1 meter. B) View to the south from the floor of trench T-1, Miller Farms site. The base of Unit 70a, marked by the light blue flags, is structurally tilted to the south for about three meters directly north of the lateral spread failure zone (the close concentration of pink and red flags in the middle distance). The structural tilting occurred during the ante-penultimate lateral spread event.

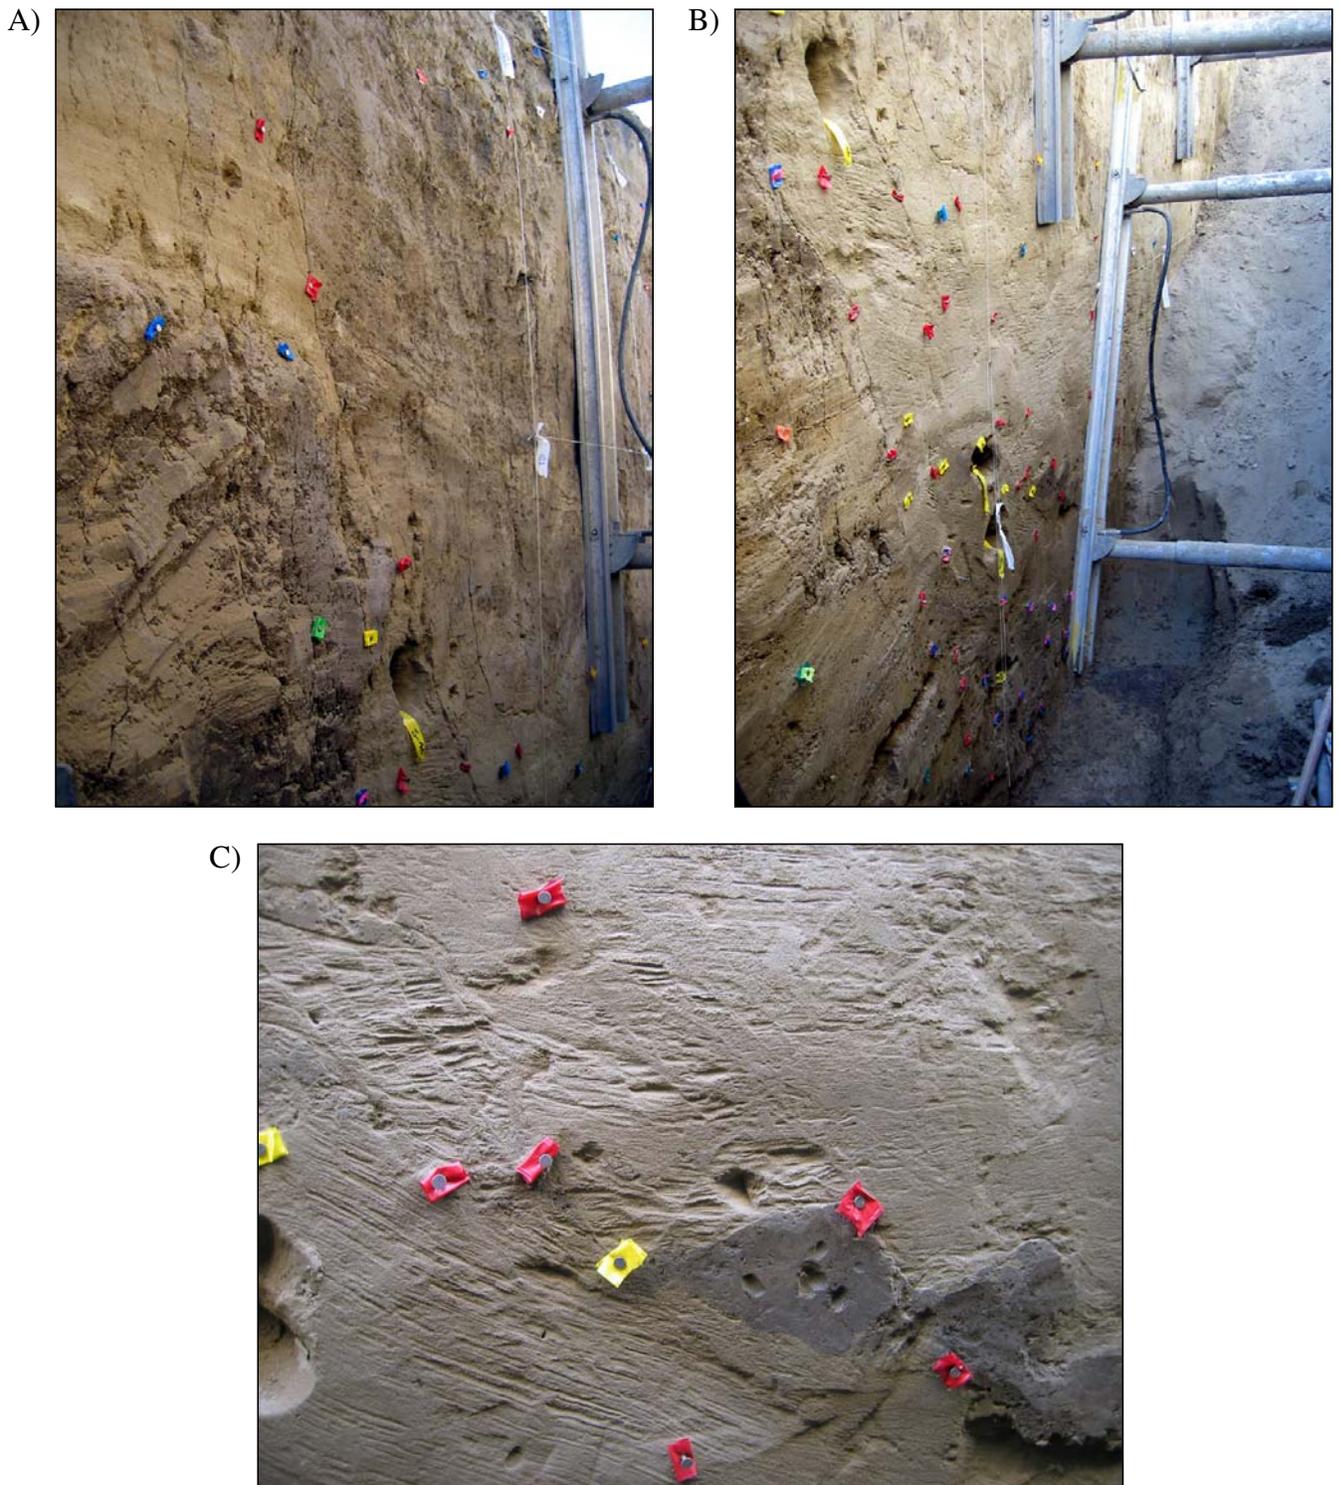
Figure 4. Photographs of trench T-2, west wall, in the zone of lateral spreading (See Plate 3 for log of trench wall). A) Upper portion of lateral spread zone, showing older floodplain deposits (on left-hand side of photo, under dark blue flags) and veneer of younger floodplain deposits (left-hand side of photo, above blue flags), juxtaposed against younger point-bar and levee deposits (right-hand part of photograph). Red flags mark normal faults within the unconformity zone that accommodated lateral spreading. B) Lower portion of unconformity and lateral spread zone. Red flags delineate normal faults that have accommodated the majority of lateral spreading failure at this location. C) Detail of the contact between units 60 and L-3. Unit 60 has sub-horizontal laminations cut by numerous steeply dipping normal faults. Unit L-3 has inclined laminations dipping north (down to the right). Dark brown silty fragments that separate the two units may have been intruded during clastic dike injection of unit L-3.
