M 5.8, 68 km SSE of Hihifo, Tonga

Origin Time: 2024-06-18 06:40:41 UTC (Mon 18:40:41 local)
Location: 16.5443° S 173.5952° W Depth: 87.0 km

PAGER Version 7

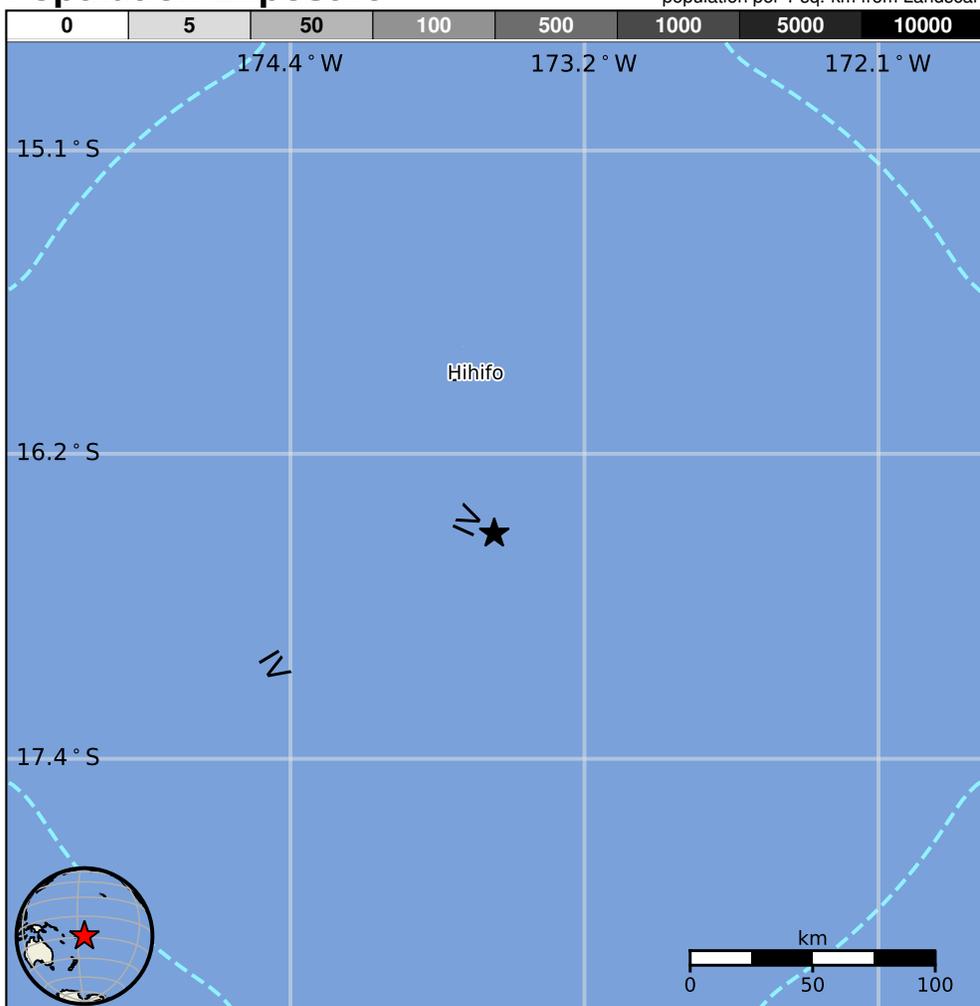
Population Exposure

Estimated Population Exposed to Earthquake Shaking

ESTIMATED POPULATION EXPOSURE (k=x1000)	—*	—*	0	0	0	0	0	0	0	
ESTIMATED MODIFIED MERCALLI INTENSITY	I	II-III	IV	V	VI	VII	VIII	IX	X+	
PERCEIVED SHAKING	Not felt	Weak	Light	Moderate	Strong	Very Strong	Severe	Violent	Extreme	
POTENTIAL DAMAGE	Resistant Structures	None	None	None	V. Light	Light	Moderate	Mod./Heavy	Heavy	V. Heavy
	Vulnerable Structures	None	None	None	Light	Moderate	Mod./Heavy	Heavy	V. Heavy	V. Heavy

*Estimated exposure only includes population within the map area.
